KARKLOOF RIVER WALK AQUATIC AND RIPARIAN ASSESSMENT

FINAL REPORT

26 - 31 March 2017

Project: GT0835

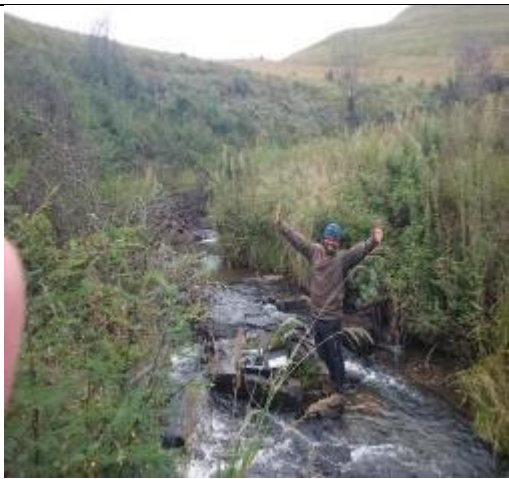
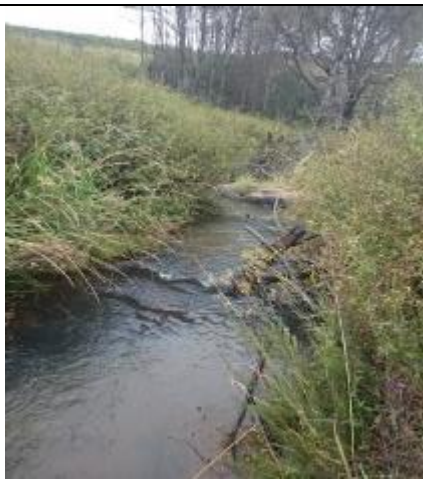
Longitude (E) DD	30.201259		
Aquatic Assessments			
MiniSASS			
Total score	27		
No. Groups	5		
Average score	5.4		
Condition	Poor		
RHA			
Score	5		
% transformed	12.5		
Condition	Good		
In situ and chemical water quality		Clarity (cm)	54
Temperature (°C)	14.46	pH	7.1
Dissolved oxygen %	58.7	<i>E. coli</i> (mpn/100ml)	140
Electrical Conductivity (mS/m)	4.9	Nitrate (mg/l)	<0.18
Total dissolved salts (mg/l)	49	Orthophosphate(mg/l)	0.086
Description: Evaluation for the RHA started from below a small water fall and continued to directly below the dam. There were grape vines growing over the sample site for the miniSASS. This section was the first where an invasive willow species was noticed. There was a sheer cliff face on one side and gentle incline on other. This was the first reach where litter was evident. A noticeable flow and volume increase compared to the previous sites was observed and is related to input from an upstream tributary. The sample site was near a log jam causing some inundation and the water was somewhat discoloured but still relatively clear (54cm clarity). The miniSASS result indicated a poor score. This is related to limited habitat and potentially as a result of the water discolouration. Water chemistry was mostly in a good condition as well. The dissolved oxygen was a little low but not seriously so. The <i>E. coli</i> was not suitable for domestic use and caution should be used if the water is to be used for irrigation.

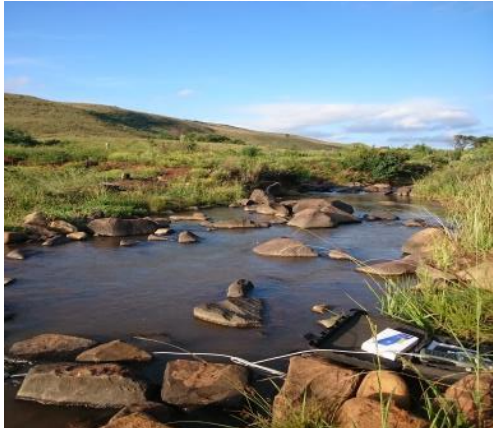
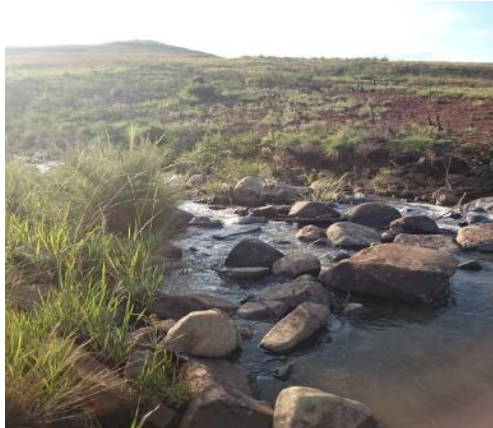
Longitude (E) DD	30.166406		
Aquatic Assessments			
MiniSASS			
Total score	48		
No. Groups	5		
Average score	9.6		
Condition	Natural		
RHA			
Score	8.5		
% transformed	21.25		
Condition	Good		
In situ and chemical water quality		Clarity (cm)	36
Temperature (°C)	15.04	pH	7.1
Dissolved oxygen %	60.2	E. coli (mpn/100ml)	ns
Electrical Conductivity (mS/m)	6.0	Nitrate (mg/l)	ns
Total dissolved salts (mg/l)	30	Orthophosphate(mg/l)	ns
Description: This was the first site where the sensitive stonefly (<i>Perlidae sp.</i>) was found. Upstream of the sample site was extensive invasion by exotic vegetation but in a limited area and an area where bad erosion was evident. From this point on the system slows down below the sample site and begins to meander. In general the water quality and riparian areas were in a near to natural and good condition respectively. The on-site water chemistry was within specification.

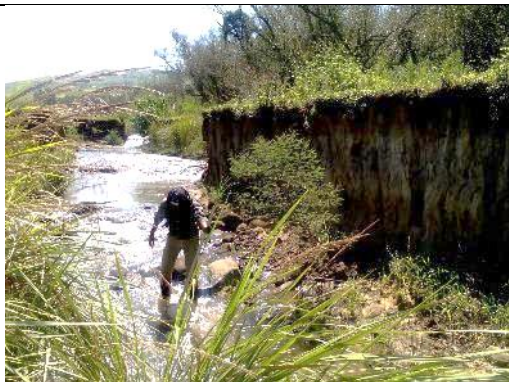
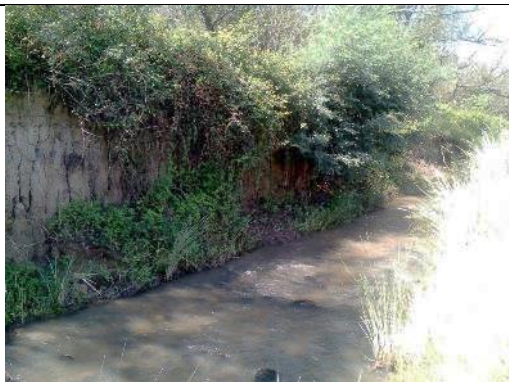
Longitude (E) DD	30.213564		
Aquatic Assessments			
MiniSASS			
Total score	35		
No. Groups	7		
Average score	5.0		
Condition	Very poor		
RHA			
Score	ns		
% transformed	ns		
Condition	ns		
In situ and chemical water quality		Clarity (cm)	45
Temperature (°C)	15.13	pH	7.5
Dissolved oxygen %	63.9	<i>E. coli</i> (mpn/100ml)	80
Electrical Conductivity (mS/m)	11.1	Nitrate (mg/l)	<0.18
Total dissolved salts (mg/l)	54	Orthophosphate(mg/l)	0.035
Description: This was the first site to score very poor. The results were impacted by the decline of instream habitat where bedrock habitat was dominant. It is also located downstream of 3 smaller tributaries that pass through low intensity housing, forestry and agriculture. Alien plants and erosion also contributed to this low score. The water quality parameters were within acceptable ranges, except <i>E. coli</i> which was too high for domestic use and irrigation.

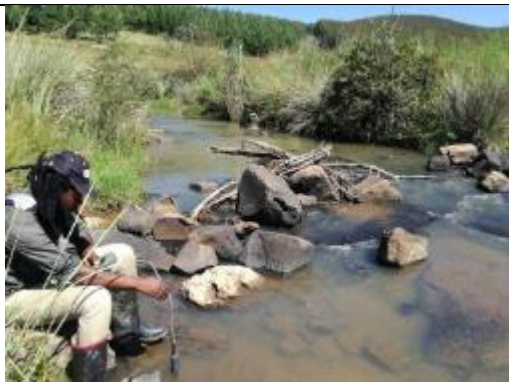
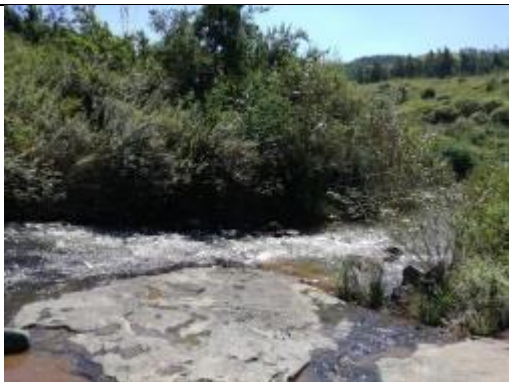
Longitude (E) DD	30.141053		
Aquatic Assessments			
MiniSASS			
Total score	36		
No. Groups	7		
Average score	5.1		
Condition	Very poor		
RHA			
Score	ns		
% transformed	ns		
Condition	ns		
In situ and chemical water quality		Clarity (cm)	49
Temperature (°C)	16.16	pH	7.32
Dissolved oxygen %	55.0	E. coli (mpn/100ml)	ns
Electrical Conductivity (mS/m)	8.6	Nitrate (mg/l)	ns
Total dissolved salts (mg/l)	42	Orthophosphate(mg/l)	ns
Description: The site was in plantation and agricultural land use, change of land owner. There was decline of instream habitat; the most abundant habitat was mud and clay. The water quality at site was still very poor according to the miniSASS results and there was a minor decline in the water chemistry results as well. Erosion was evident at the site. The first site to notice knot or smartweed (<i>Persicaria lapathifolia</i>) which is often associated with organic enrichment such as sewage or fertilizer.

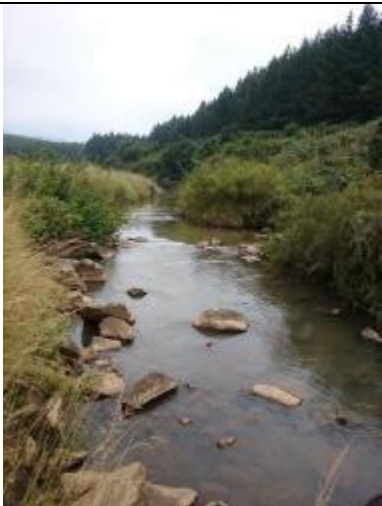
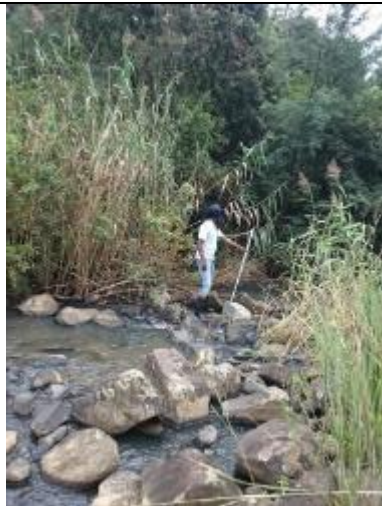
Upstream view from sample site		Downstream view from sample site	
Day 3	Site 14	Water Management Area	uMvoti to uMzimkhulu
River	Karkloof	1:50000 map reference	2930AC
Quaternary Catchment	U20D	Aquatic Ecoregion	South eastern Uplands
Latitude (S) DD	-29.323414		
Longitude (E) DD	30.180752		
Aquatic Assessments			
MiniSASS			
Total score	44		
No. Groups	8		
Average score	5.5		
Condition	Poor		
RHA			
Score	ns		
% transformed	ns		
Condition	ns		
In situ and chemical water quality		Clarity (cm)	50
Temperature (°C)	16.45	pH	7.45
Dissolved oxygen %	72.3	E. coli (mpn/100ml)	52
Electrical Conductivity (mS/m)	7.1	Nitrate (mg/l)	<0.18
Total dissolved salts (mg/l)	36	Orthophosphate(mg/l)	<0.03
Description: This site was dominated by boulders with other limited habitats. The miniSASS results indicated the site was in a poor condition, while the water chemistry results were in acceptable ranges. The miniSASS result may have been impacted by the limited habitat or from inputs from the tributary upstream of the site which was also affecting habitat, as there is erosion occurring in the upper reaches of the tributary.

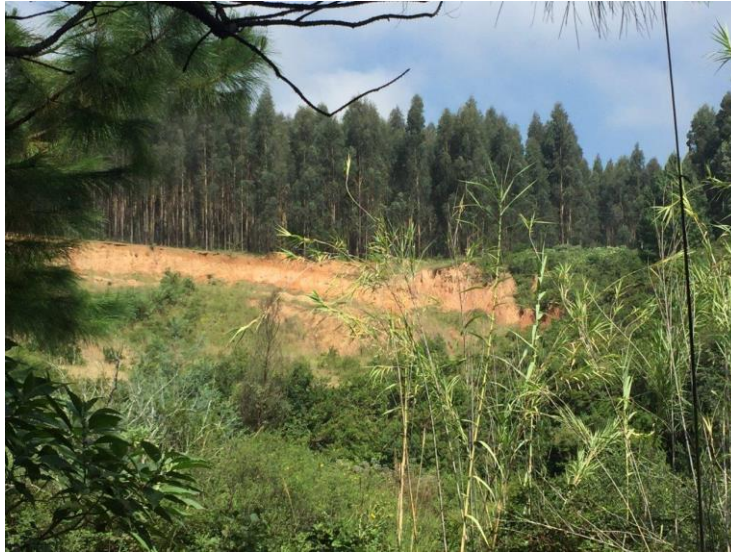
One area stood out due to severe erosion pictured above. This reach was the first section where Formosa lily was seen and it was found along most of the reach.

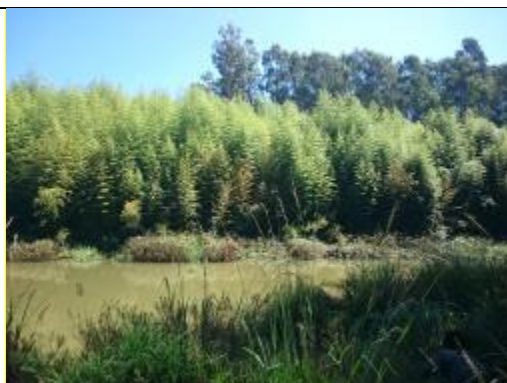
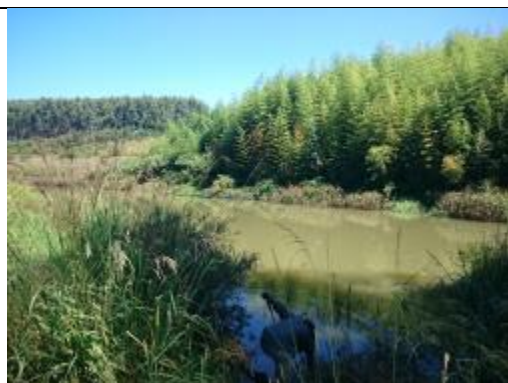
Longitude (E) DD	30.27930		
Aquatic Assessments			
MiniSASS			
Total score	ns		
No. Groups	ns		
Average score	ns		
Condition	ns		
RHA			
Score	6.5		
% transformed	16.25		
Condition	Good		
In situ and chemical water quality		Clarity (cm)	40
Temperature (°C)	18.01	pH	6.83
Dissolved oxygen %	76.7	E. coli (mpn/100ml)	10000
Electrical Conductivity (mS/m)	6.4	Nitrate (mg/l)	0.42
Total dissolved salts (mg/l)	34	Orthophosphate(mg/l)	<0.03
Description: The site is approximately 10 meters upstream of Karkloof bridge on the Crammond road. The river had passed through approximately 5km of degraded wetland between site27 and site 28. This was the first site with very high E. coli counts. There is a tributary that joins the Karkloof between sites 27 and 28, which may have contributed to the higher E. coli counts. The RHA results indicate the site to be in a good condition; however the site had large areas of Common Reed (<i>Phragmites australis</i>) which can indicate degradation. In certain sections extensive bramble (<i>R. cuneifolius</i>) coverage was a concern.

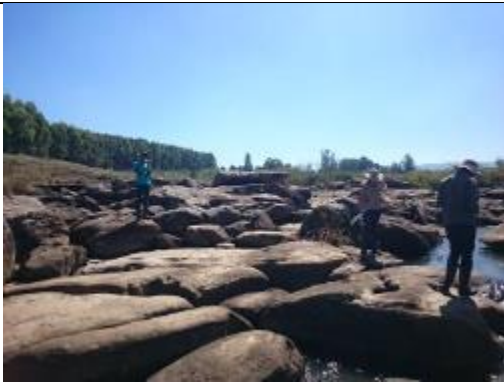
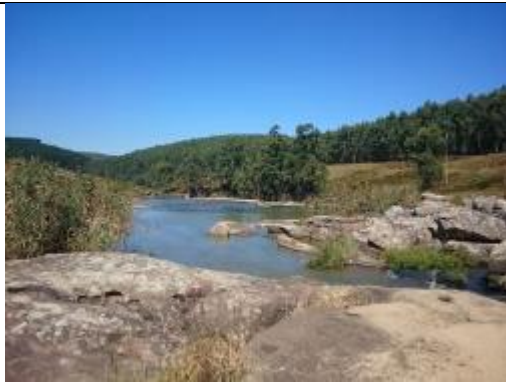
Longitude (E) DD	30.27229		
Aquatic Assessments			
MiniSASS			
Total score	ns		
No. Groups	ns		
Average score	ns		
Condition	ns		
RHA			
Score	ns		
% transformed	ns		
Condition	ns		
In situ and chemical water quality		Clarity (cm)	ns
Temperature (°C)	ns	pH	ns
Dissolved oxygen %	ns	<i>E. coli</i> (mpn/100ml)	2300
Electrical Conductivity (mS/m)	ns	Nitrate (mg/l)	0.5
Total dissolved salts (mg/l)	ns	Orthophosphate(mg/l)	0.044
Description: The river was approximately 12 metres wide and more than half a metre deep at this site. The flatter topography and wider river resulted in slower flows. Maize was being grown in the reach upstream. Only water chemistry samples were collected at this site and these showed an increase in nitrate and orthophosphate. These nutrients are normally related to fertilizers.

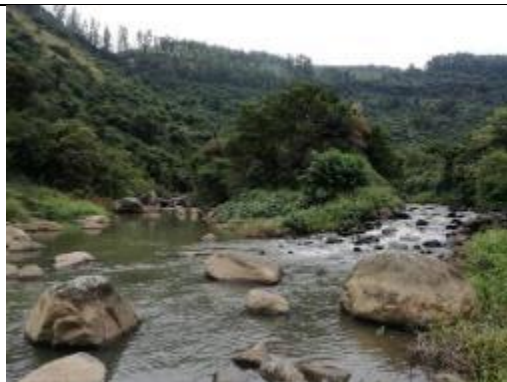
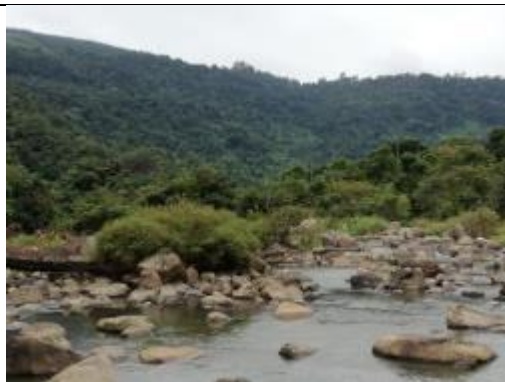
Longitude (E) DD	30.27810		
Aquatic Assessments			
MiniSASS			
Total score	ns		
No. Groups	ns		
Average score	ns		
Condition	ns		
RHA			
Score	ns		
% transformed	ns		
Condition	ns		
In situ and chemical water quality		Clarity (cm)	63
Temperature (°C)	18.81	pH	7.42
Dissolved oxygen %	81.1	<i>E. coli</i> (mpn/100ml)	310
Electrical Conductivity (mS/m)	7.0	Nitrate (mg/l)	0.66
Total dissolved salts (mg/l)	35	Orthophosphate(mg/l)	0.034
Description: Site 32 was located below falls along the boardwalk and was the closest accessible site downstream of the falls. This section of the river predominantly flows around large boulders. The site is in a valley where the river banks are steep and well covered with dense indigenous vegetation. The nutrients, nitrate and orthophosphate were marginally higher than seen at site 31. <i>E. coli</i> was still higher than the recommended target range for domestic use and irrigation.
