KARKLOOF RIVER WALK AQUATIC AND RIPARIAN ASSESSMENT

FINAL REPORT

26 - 31 March 2017

Project: GT0835

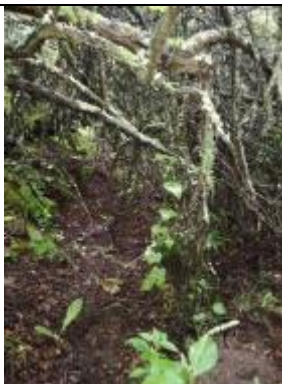
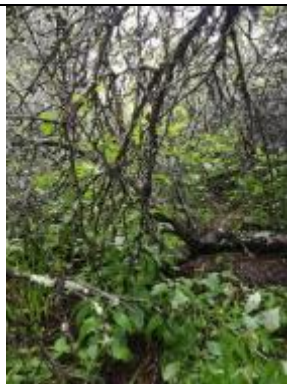
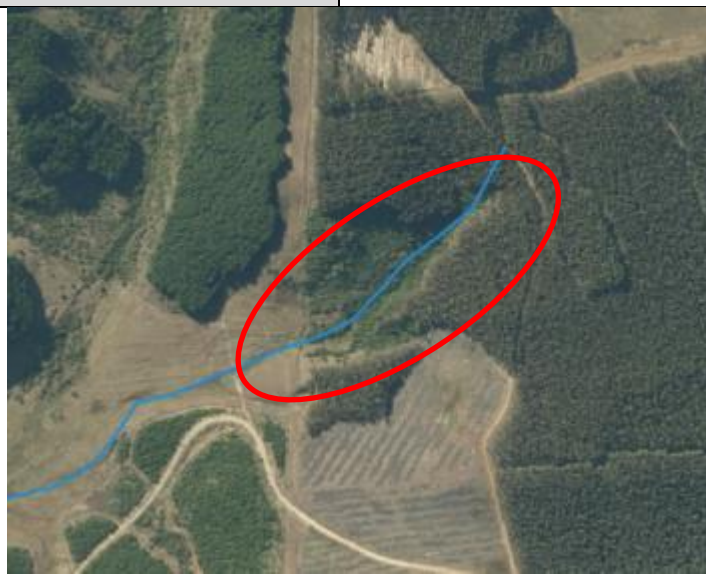
Upstream view from sample site		Downstream view from sample site	
Day 1	Site 1	Water Management Area	uMvoti to uMzimkhulu
River	Karkloof	1:50000 map reference	2930AC
Quaternary Catchment	U20D	Aquatic Ecoregion	South eastern Uplands
Latitude (S) DD	-29.258056

Longitude (E) DD	30.209201		
Aquatic Assessments			
MiniSASS			
Total score	ns		
No. Groups	ns		
Average score	ns		
Condition	ns		
RHA			
Score	2		
% transformed	5		
Condition	Natural		
In situ and chemical water quality		Clarity (cm)	ns
Temperature (°C)	ns	pH	ns
Dissolved oxygen (%)	ns	<i>E. coli</i> (mpn/100ml)	ns
Electrical Conductivity (mS/m)	ns	Nitrate/Nitrite (mg/L)	ns
Total dissolved salts (mg/l)	ns	Orthophosphate (mg/l)	ns
Description: This site is at the source of the Karkloof River and was dry at the time of the river walk so only a riparian health audit was done at the site. The upper reaches of the catchment are surrounded by, or are in plantations. The drainage line which constitutes the uppermost reach of the Karkloof river is located in a stand of Ouhout trees (<i>Leucosidea sericea</i>). The lack of water this high up in the catchment is not unusual due to the relatively small size of the catchment but limited the assessments that could be done at the site. The overall condition of the site is considered to be in a near to natural condition.

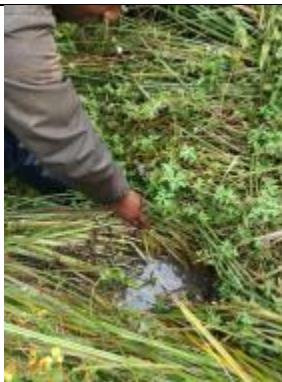
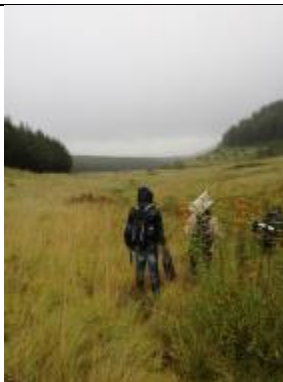
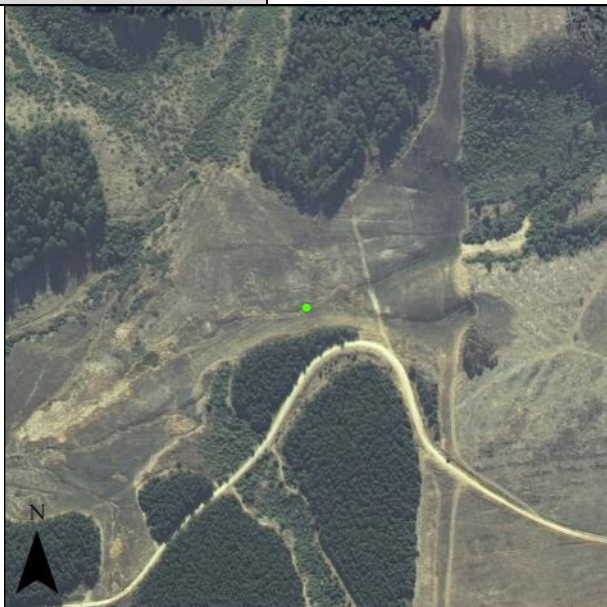
View of sample point		Downstream view from sample site	
Day 1	Site 2	Water Management Area	uMvoti to uMzimkhulu
River	Karkloof	1:50000 map reference	2930AC
Quaternary Catchment	U20D	Aquatic Ecoregion	South eastern Uplands
Latitude (S) DD	-29.259171

Longitude (E) DD	30.206844		
Aquatic Assessments			
MiniSASS			
Total score	ns		
No. Groups	ns		
Average score	ns		
Condition	ns		
RHA			
Score	ns		
% transformed	ns		
Condition	ns		
In situ and chemical water quality		Clarity (cm)	ns
Temperature (°C)	15.17	pH	6.43
Dissolved oxygen (%)	37.5	<i>E. coli</i> (mpn/100ml)	ns
Electrical Conductivity (mS/m)	4.8	Nitrate/Nitrite (mg/L)	ns
Total dissolved salts (mg/l)	24	Orthophosphate (mg/l)	ns
Description: This site was located in the open grassy valley below the Ouhout covered drainage line that is the source of the Karkloof River. This site was the first place where surface water was available for sampling, but still being high up in the catchment the volume was limited and only <i>in-situ</i> water quality could be sampled. This site was the first point along the walk where signs of bramble and bugweed were present. Dissolved oxygen was the only parameter outside of the recommended range, however, this is not of concern because this site was still high up in the catchment, and the river had no chance to tumble/cascade/encounter rapids/ waterfalls etc. and as such had little opportunity to absorb oxygen.

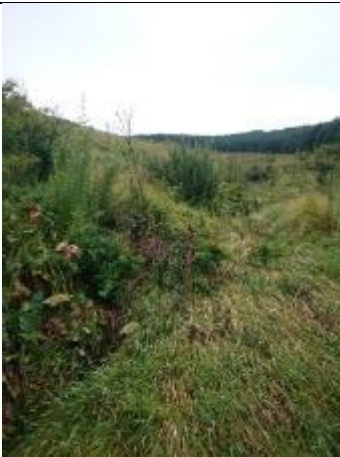
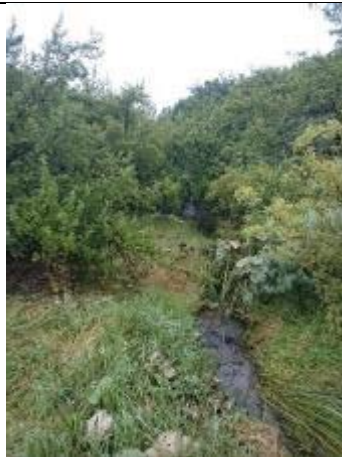
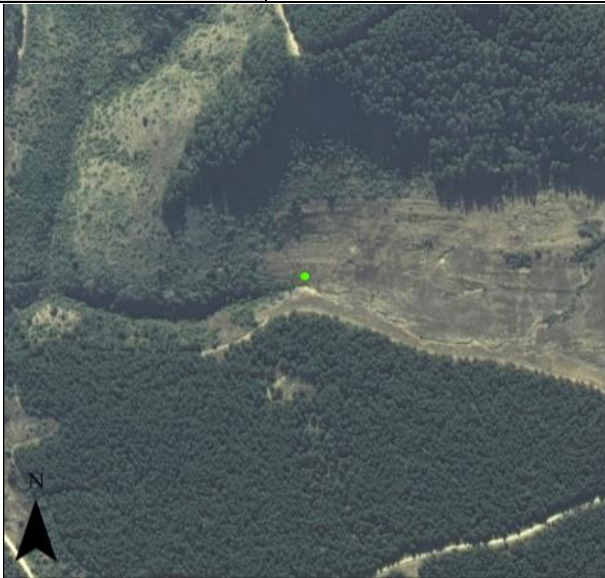
Upstream view from sample site		Downstream view from sample site	
Day 1	Site 3	Water Management Area	uMvoti to uMzimkhulu
River	Karkloof	1:50000 map reference	2930AC
Quaternary Catchment	U20D	Aquatic Ecoregion	South eastern Uplands
Latitude (S) DD	-29.25994

Longitude (E) DD	30.20136		
Aquatic Assessments			
MiniSASS			
Total score	33		
No. Groups	5		
Average score	6.6		
Condition	Good		
RHA			
Score	4		
% transformed	10		
Condition	Natural		
In situ and chemical water quality		Clarity (cm)	25
Temperature (°C)	14.3	pH	7.4
Dissolved oxygen (%)	61.1	<i>E. coli</i> (mpn/100ml)	ns
Electrical Conductivity (mS/m)	8.6	Nitrate/Nitrite (mg/L)	ns
Total dissolved salts (mg/l)	43	Orthophosphate (mg/l)	ns
Description: This site was located upstream of a small waterfall and was surrounded by a stand of Ouhout and predominantly natural vegetation as indicated by the near to natural RHA score. However, bramble, wattle, pine and erosion were having a minor impact on this reach. The site provided the first encounter with bedrock and thanks to increased flows and volumes of water, this was the first site with sufficient habitat to conduct a miniSASS assessment. The miniSASS score showed a good condition, which is lower than expected and related to the limited habitat rather than water quality. Dissolved oxygen was lower than the recommended target water quality range, but this is not unexpected for a small stream this high up in the catchment where the limited stones habitat has not allowed time for the water to tumble and generate the dissolved oxygen. From the point below the waterfall, an increase in the percentage exotic vegetation was noted and weed control for this area is recommended.

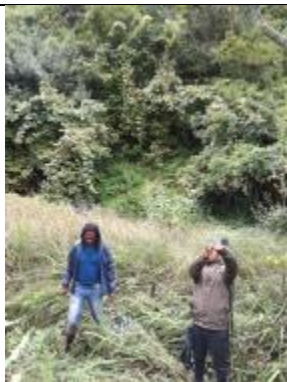
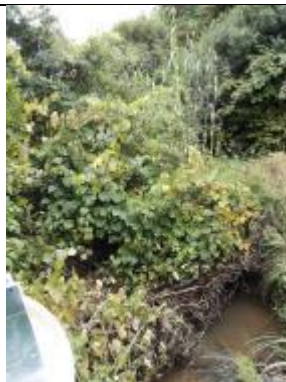
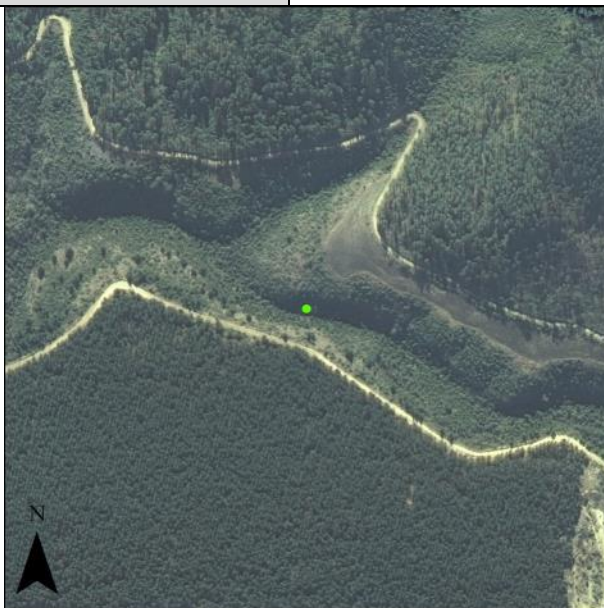
View of riparian area at sample site		Downstream view from sample site	
Day 1	Site 4	Water Management Area	uMvoti to uMzimkhulu
River	Karkloof	1:50000 map reference	2930AC
Quaternary Catchment	U20D	Aquatic Ecoregion	South eastern Uplands
Latitude (S) DD	-29.260238

Longitude (E) DD	30.201259		
Aquatic Assessments			
MiniSASS			
Total score	27		
No. Groups	5		
Average score	5.4		
Condition	Poor		
RHA			
Score	5		
% transformed	12.5		
Condition	Good		
In situ and chemical water quality		Clarity (cm)	54
Temperature (°C)	14.46	pH	7.1
Dissolved oxygen %	58.7	<i>E. coli</i> (mpn/100ml)	140
Electrical Conductivity (mS/m)	4.9	Nitrate (mg/l)	<0.18
Total dissolved salts (mg/l)	49	Orthophosphate(mg/l)	0.086
Description: Evaluation for the RHA started from below a small water fall and continued to directly below the dam. There were grape vines growing over the sample site for the miniSASS. This section was the first where an invasive willow species was noticed. There was a sheer cliff face on one side and gentle incline on other. This was the first reach where litter was evident. A noticeable flow and volume increase compared to the previous sites was observed and is related to input from an upstream tributary. The sample site was near a log jam causing some inundation and the water was somewhat discoloured but still relatively clear (54cm clarity). The miniSASS result indicated a poor score. This is related to limited habitat and potentially as a result of the water discolouration. Water chemistry was mostly in a good condition as well. The dissolved oxygen was a little low but not seriously so. The <i>E. coli</i> was not suitable for domestic use and caution should be used if the water is to be used for irrigation.

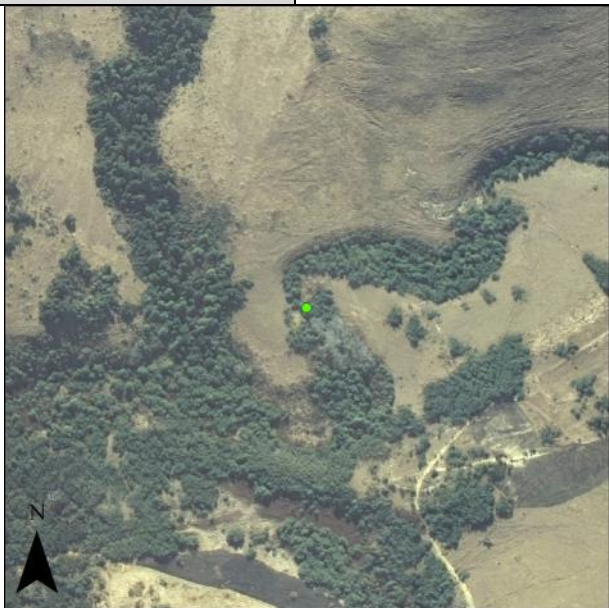
Upstream view from sample site		Downstream view from sample site	
Day 1	Site 5	Water Management Area	uMvoti to uMzimkhulu
River	Karkloof	1:50000 map reference	2930AC
Quaternary Catchment	U20D	Aquatic Ecoregion	South eastern Uplands
Latitude (S) DD	-29.262978

Longitude (E) DD	30.180571		
Aquatic Assessments			
MiniSASS			
Total score	40		
No. Groups	6		
Average score	6.6		
Condition	Good		
RHA			
Score	4.5		
% transformed	11.25		
Condition	Good		
In situ and chemical water quality		Clarity (cm)	48
Temperature (°C)	15.04	pH	7.6
Dissolved oxygen %	60.2	E. coli (mpn/100ml)	ns
Electrical Conductivity (mS/m)	6.0	Nitrate (mg/l)	ns
Total dissolved salts (mg/l)	38	Orthophosphate(mg/l)	ns
Description: Open grassland after Plantation. Both the miniSASS and RHA results show this reach to be in a good condition, the water chemistry was also within the acceptable range except for a low dissolved oxygen score but as before, the river at this point has had limited opportunities to absorb oxygen.

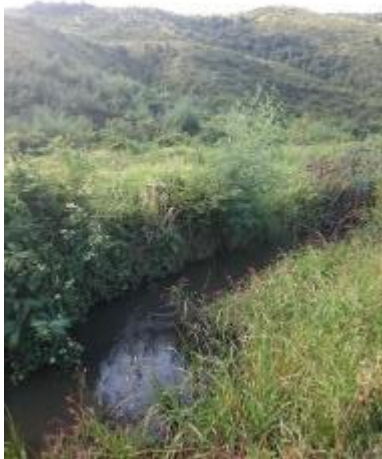
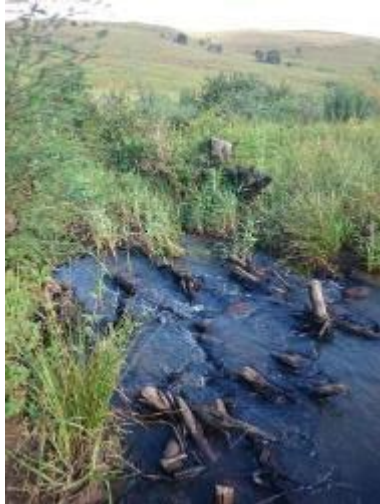
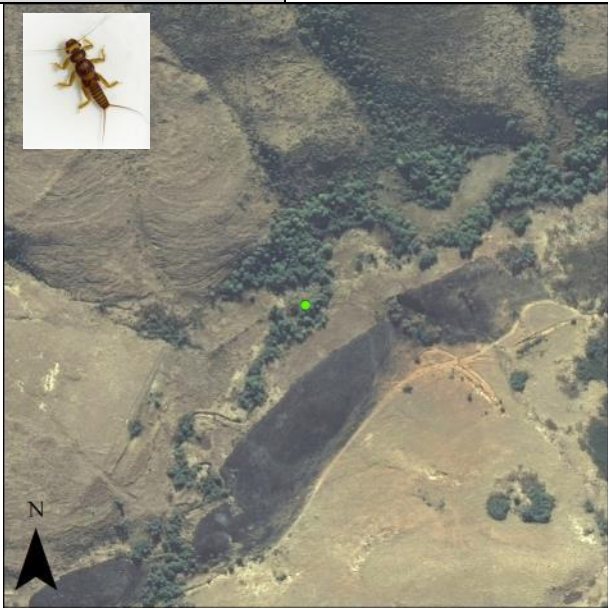
Upstream view from sample site		Downstream view from sample site	
Day 1	Site 6	Water Management Area	uMvoti to uMzimkhulu
River	Karkloof	1:50000 map reference	2930AC
Quaternary Catchment	U20D	Aquatic Ecoregion	South eastern Uplands
Latitude (S) DD	-29.267601

Longitude (E) DD	30.166406		
Aquatic Assessments			
MiniSASS			
Total score	48		
No. Groups	5		
Average score	9.6		
Condition	Natural		
RHA			
Score	8.5		
% transformed	21.25		
Condition	Good		
In situ and chemical water quality		Clarity (cm)	36
Temperature (°C)	15.04	pH	7.1
Dissolved oxygen %	60.2	E. coli (mpn/100ml)	ns
Electrical Conductivity (mS/m)	6.0	Nitrate (mg/l)	ns
Total dissolved salts (mg/l)	30	Orthophosphate(mg/l)	ns
Description: This was the first site where the sensitive stonefly (<i>Perlidae sp.</i>) was found. Upstream of the sample site was extensive invasion by exotic vegetation but in a limited area and an area where bad erosion was evident. From this point on the system slows down below the sample site and begins to meander. In general the water quality and riparian areas were in a near to natural and good condition respectively. The on-site water chemistry was within specification.

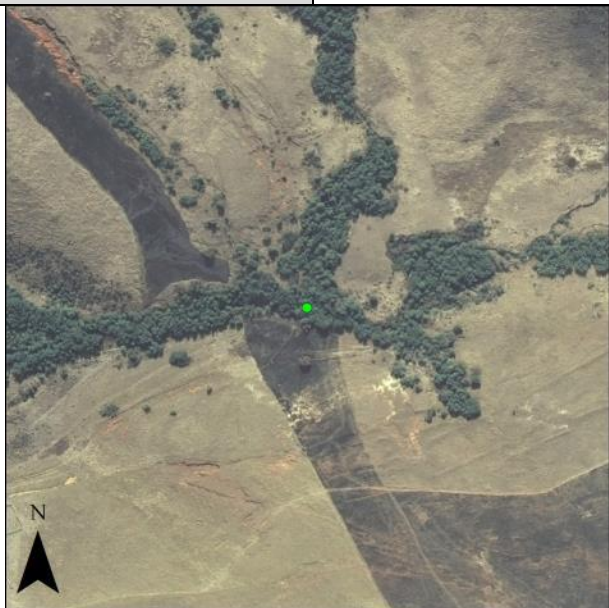
Upstream view from sample site		Downstream view from sample site	
Day 1	Site 7	Water Management Area	uMvoti to uMzimkhulu
River	Karkloof	1:50000 map reference	2930AC
Quaternary Catchment	U20D	Aquatic Ecoregion	South eastern Uplands
Latitude (S) DD	-29.27310

Longitude (E) DD	30.15056		
Aquatic Assessments			
MiniSASS			
Total score	48		
No. Groups	8		
Average score	6a		
Condition	Fair		
RHA			
Score	9.0		
% transformed	22.50		
Condition	Good		
In situ and chemical water quality		Clarity (cm)	ns
Temperature (°C)	ns	pH	ns
Dissolved oxygen %	ns	E. coli (mpn/100ml)	92
Electrical Conductivity (mS/m)	ns	Nitrate (mg/l)	<0.18
Total dissolved salts (mg/l)	ns	Orthophosphate(mg/l)	<0.03
Description: This site was the rockiest site of day one. The miniSASS score indicated that the water quality was fair; this was influenced by the habitat available which was limiting. The RHA indicated that the riparian areas were in a good condition, although there were some erosion evident and bare areas following the clearing of some exotic vegetation along the river and a nearby upstream tributary.

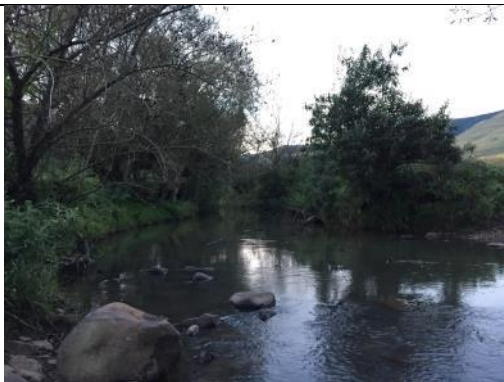
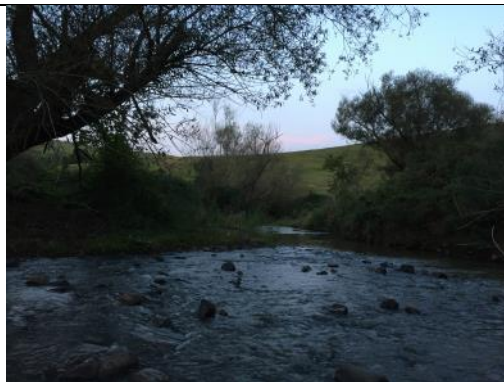
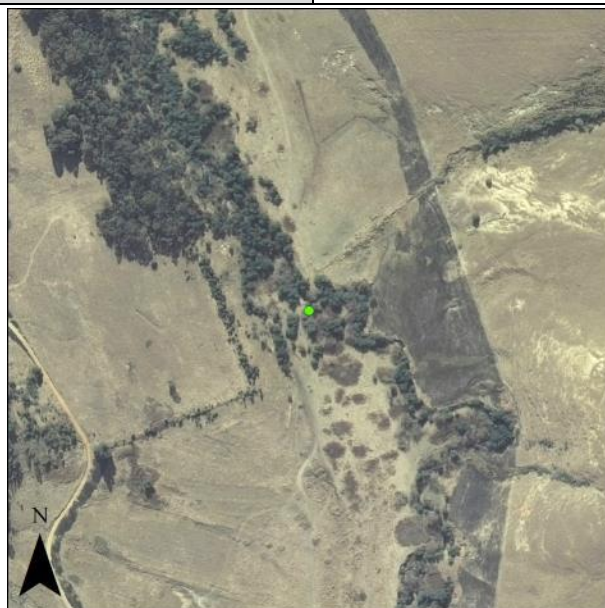
Upstream view from sample site		Downstream view from sample site	
Day 1	Site 8	Water Management Area	uMvoti to uMzimkhulu
River	Karkloof	1:50000 map reference	2930AC
Quaternary Catchment	U20D	Aquatic Ecoregion	South eastern Uplands
Latitude (S) DD	-29.280704

Longitude (E) DD	30.129396		
Aquatic Assessments			
MiniSASS			
Total score	47		
No. Groups	8		
Average score	5.8		
Condition	Fair		
RHA			
Score	13.5		
% transformed	33.75		
Condition	Fair		
In situ and chemical water quality		Clarity (cm)	51
Temperature (°C)	14.52	pH	8.25
Dissolved oxygen %	64.7	<i>E. coli</i> (mpn/100ml)	ns
Electrical Conductivity (mS/m)	8.4	Nitrate (mg/l)	ns
Total dissolved salts (mg/l)	42	Orthophosphate(mg/l)	ns
Description: The final site of day 1. Water quality and riparian habitat were both in a fair condition. The riparian assessment for this reach found erosion and exotic vegetation to be problematic, there was also some litter present along the reach, and these accounted for the fair condition. The miniSASS scores would also have been impacted by the alien vegetation and erosion by altering habitat and food availability

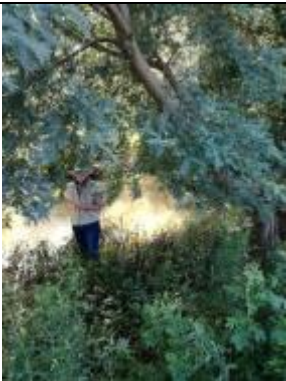
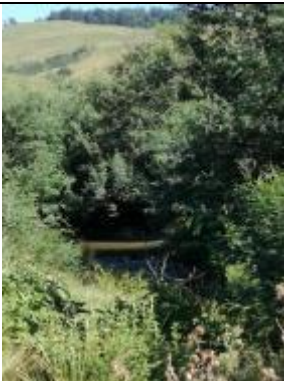
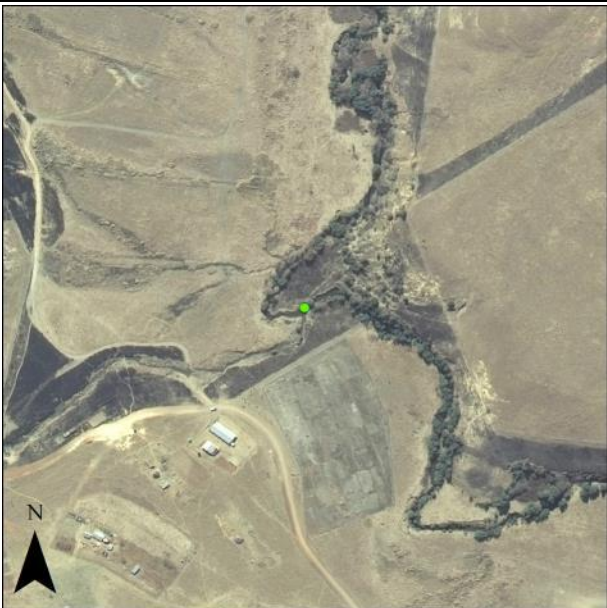
Upstream view from sample site		Downstream view from sample site	
Day 2	Site 9	Water Management Area	uMvoti to uMzimkhulu
River	Karkloof	1:50000 map reference	2930AC
Quaternary Catchment	U20D	Aquatic Ecoregion	South eastern Uplands
Latitude (S) DD	-29.421787

Longitude (E) DD	30.213564		
Aquatic Assessments			
MiniSASS			
Total score	35		
No. Groups	7		
Average score	5.0		
Condition	Very poor		
RHA			
Score	ns		
% transformed	ns		
Condition	ns		
In situ and chemical water quality		Clarity (cm)	45
Temperature (°C)	15.13	pH	7.5
Dissolved oxygen %	63.9	<i>E. coli</i> (mpn/100ml)	80
Electrical Conductivity (mS/m)	11.1	Nitrate (mg/l)	<0.18
Total dissolved salts (mg/l)	54	Orthophosphate(mg/l)	0.035
Description: This was the first site to score very poor. The results were impacted by the decline of instream habitat where bedrock habitat was dominant. It is also located downstream of 3 smaller tributaries that pass through low intensity housing, forestry and agriculture. Alien plants and erosion also contributed to this low score. The water quality parameters were within acceptable ranges, except <i>E. coli</i> which was too high for domestic use and irrigation.

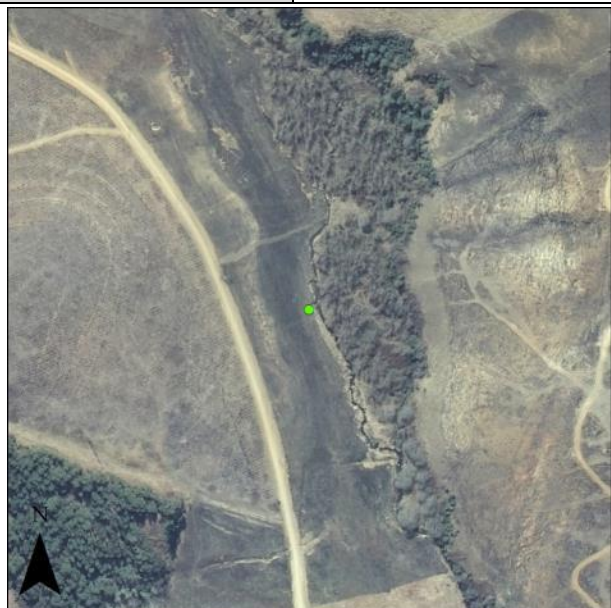
Upstream view from sample site		Downstream view from sample site	
Day 2	Site 10	Water Management Area	uMvoti to uMzimkhulu
River	Karkloof	1:50000 map reference	2930AC
Quaternary Catchment	U20D	Aquatic Ecoregion	South eastern Uplands
Latitude (S) DD	-29.296526

Longitude (E) DD	30.141053		
Aquatic Assessments			
MiniSASS			
Total score	36		
No. Groups	7		
Average score	5.1		
Condition	Very poor		
RHA			
Score	ns		
% transformed	ns		
Condition	ns		
In situ and chemical water quality		Clarity (cm)	49
Temperature (°C)	16.16	pH	7.32
Dissolved oxygen %	55.0	E. coli (mpn/100ml)	ns
Electrical Conductivity (mS/m)	8.6	Nitrate (mg/l)	ns
Total dissolved salts (mg/l)	42	Orthophosphate(mg/l)	ns
Description: The site was in plantation and agricultural land use, change of land owner. There was decline of instream habitat; the most abundant habitat was mud and clay. The water quality at site was still very poor according to the miniSASS results and there was a minor decline in the water chemistry results as well. Erosion was evident at the site. The first site to notice knot or smartweed (<i>Persicaria lapathifolia</i>) which is often associated with organic enrichment such as sewage or fertilizer.

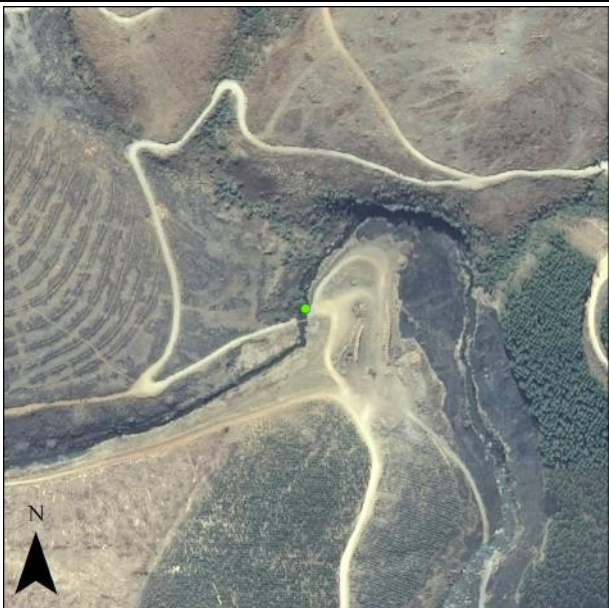
Upstream view from sample site		Downstream view from sample site	
Day 2	Site 11	Water Management Area	uMvoti to uMzimkhulu
River	Karkloof	1:50000 map reference	2930AC
Quaternary Catchment	U20D	Aquatic Ecoregion	South eastern Uplands
Latitude (S) DD	-29.299099

Longitude (E) DD	30.147188		
Aquatic Assessments			
MiniSASS			
Total score	ns		
No. Groups	ns		
Average score	ns		
Condition	ns		
RHA			
Score	ns		
% transformed	ns		
Condition	ns		
In situ and chemical water quality		Clarity (cm)	34
Temperature (°C)	17.95	pH	7.72
Dissolved oxygen %	74.6	E. coli (mpn/100ml)	ns
Electrical Conductivity (mS/m)	8.5	Nitrate (mg/l)	ns
Total dissolved salts (mg/l)	ns	Orthophosphate(mg/l)	ns
Description: This site was located near the Sappi loading zone upstream of river crossing, bedrock was common and there were reaches where the river had steep banks. In general the riparian areas were maintained by SAPPI with only a few wattle escapees and some other invasive plants present along with some felling debris. Only in-situ water chemistry was taken and this was found to be within acceptable levels.

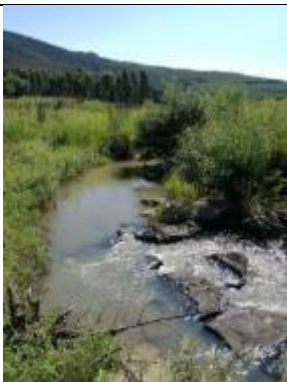
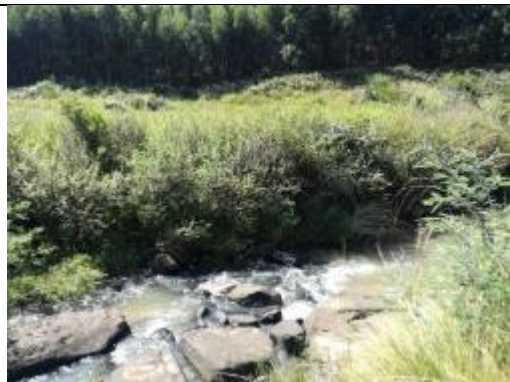
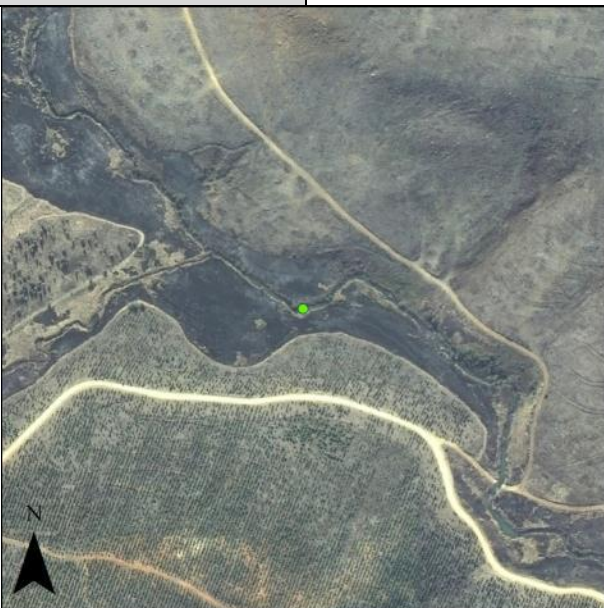
Upstream view from sample site		Downstream view from sample site	
Day 2	Site 12	Water Management Area	uMvoti to uMzimkhulu
River	Karkloof	1:50000 map reference	2930AC
Quaternary Catchment	U20D	Aquatic Ecoregion	South eastern Uplands
Latitude (S) DD	-29.30960

Longitude (E) DD	30.15190		
Aquatic Assessments			
MiniSASS			
Total score	ns		
No. Groups	ns		
Average score	ns		
Condition	ns		
RHA			
Score	ns		
% transformed	ns		
Condition	ns		
In situ and chemical water quality		Clarity (cm)	49
Temperature (°C)	20.22	pH	7.7
Dissolved oxygen %	77	<i>E. coli</i> (mpn/100ml)	ns
Electrical Conductivity (mS/m)	8.6	Nitrate (mg/l)	ns
Total dissolved salts (mg/l)	34	Orthophosphate(mg/l)	ns
Description: This was the rock site on day 2 and maintained in controlling invasive alien plants. The site had minor impact of <i>Solanum mauritianum</i> . Upstream of the site was natural grassland. Only in-situ water chemistry was collected at this site and was found to be within acceptable ranges

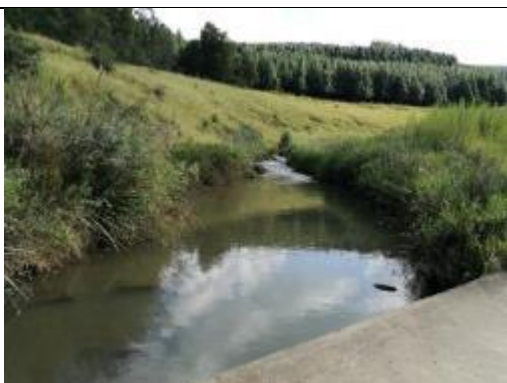
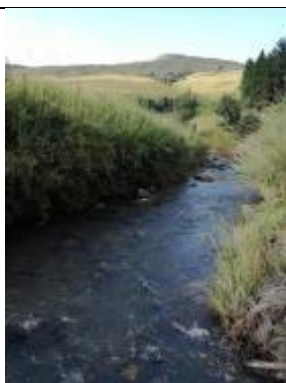
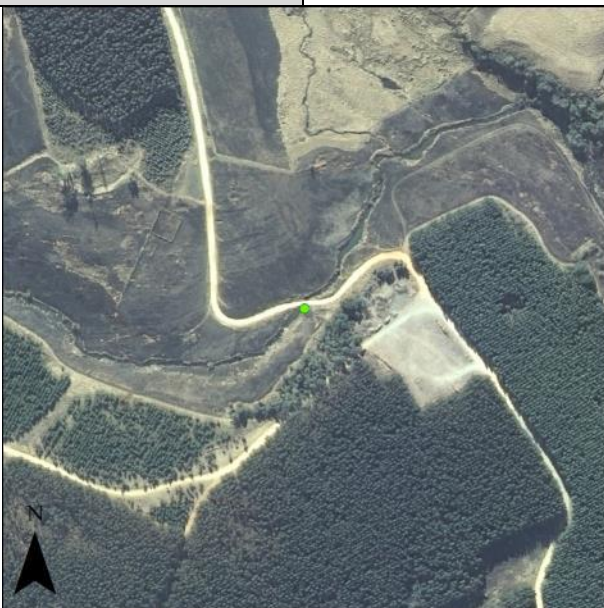
Upstream view from sample site		Downstream view from sample site	
Day 2	Site 13	Water Management Area	uMvoti to uMzimkhulu
River	Karkloof	1:50000 map reference	2930AC
Quaternary Catchment	U20D	Aquatic Ecoregion	South eastern Uplands
Latitude (S) DD	-29.319233

Longitude (E) DD	30.169473		
Aquatic Assessments			
MiniSASS			
Total score	47		
No. Groups	8		
Average score	5.9		
Condition	Fair		
RHA			
Score	7.0		
% transformed	17.5		
Condition	Good		
In situ and chemical water quality		Clarity (cm)	47
Temperature (°C)	19.05	pH	7.56
Dissolved oxygen %	76	E. coli (mpn/100ml)	ns
Electrical Conductivity (mS/m)	8.6	Nitrate (mg/l)	ns
Total dissolved salts (mg/l)	43	Orthophosphate(mg/l)	ns
Description: On Sappi plantation near a road crossing, upstream of the road the water is slower flowing possible as a result of the bridge, downstream the speed of the river increases, the miniSASS results improved to a fair condition and the riparian assessments improved to a good condition. Habitat also improved at this site compared to those upstream earlier on day 2 with more variety was present. Upstream of the site had good instream habitat, mostly rocky habitat. Water chemistry was also within acceptable ranges.

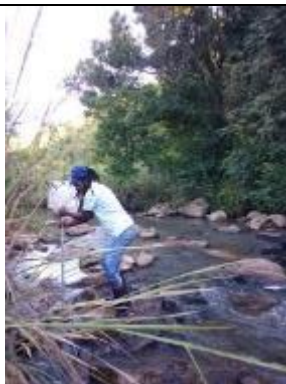
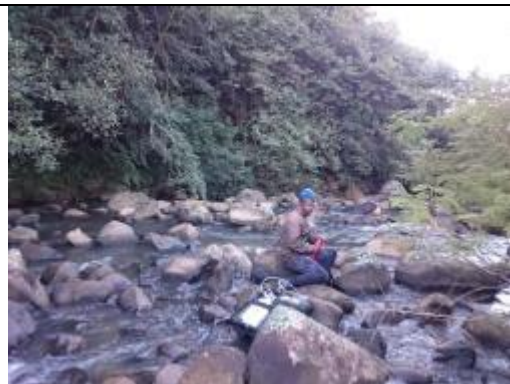
Upstream view from sample site		Downstream view from sample site	
Day 3	Site 14	Water Management Area	uMvoti to uMzimkhulu
River	Karkloof	1:50000 map reference	2930AC
Quaternary Catchment	U20D	Aquatic Ecoregion	South eastern Uplands
Latitude (S) DD	-29.323414		
Longitude (E) DD	30.180752		
Aquatic Assessments			
MiniSASS			
Total score	44		
No. Groups	8		
Average score	5.5		
Condition	Poor		
RHA			
Score	ns		
% transformed	ns		
Condition	ns		
In situ and chemical water quality		Clarity (cm)	50
Temperature (°C)	16.45	pH	7.45
Dissolved oxygen %	72.3	E. coli (mpn/100ml)	52
Electrical Conductivity (mS/m)	7.1	Nitrate (mg/l)	<0.18
Total dissolved salts (mg/l)	36	Orthophosphate(mg/l)	<0.03
Description: This site was dominated by boulders with other limited habitats. The miniSASS results indicated the site was in a poor condition, while the water chemistry results were in acceptable ranges. The miniSASS result may have been impacted by the limited habitat or from inputs from the tributary upstream of the site which was also affecting habitat, as there is erosion occurring in the upper reaches of the tributary.

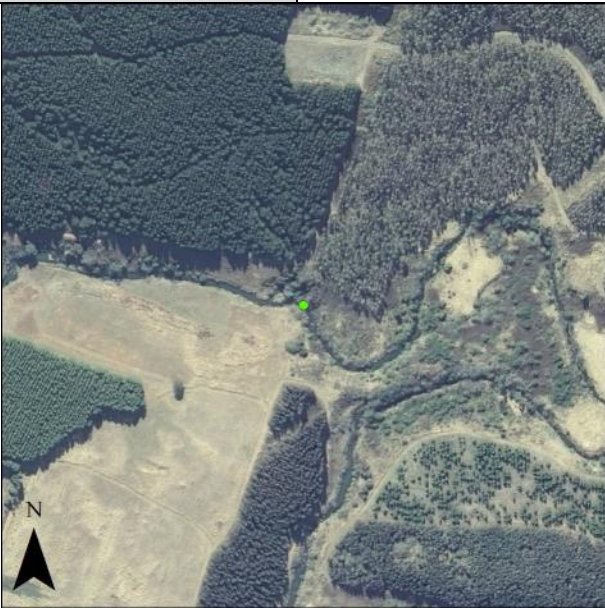
Longitude (E) DD	30.195221		
Aquatic Assessments			
MiniSASS			
Total score	36		
No. Groups	5		
Average score	7.2		
Condition	Natural		
RHA			
Score	5.5		
% transformed	13.5		
Condition	Good		
In situ and chemical water quality		Clarity (cm)	46
Temperature (°C)	17.87	pH	7.45
Dissolved oxygen %	77.6	E. coli (mpn/100ml)	28
Electrical Conductivity (mS/m)	7.1	Nitrate (mg/l)	<0.18
Total dissolved salts (mg/l)	36	Orthophosphate(mg/l)	<0.03
Description: The site was below a local soccer field and above a small path crossing the river. The river had passed through a fairly healthy section with improved instream habitat conditions and the riparian habitat results also indicated a good condition. The miniSASS results showed the system was in a near to natural condition. The water chemistry results were in acceptable ranges. Downstream of the site the riparian areas became badly invaded by exotic plants, the main culprit being bramble (<i>Rubus cuneifolius</i>).

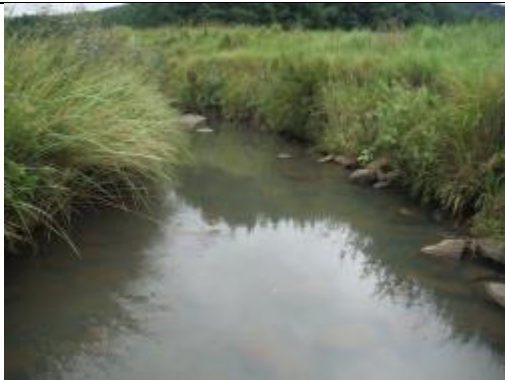
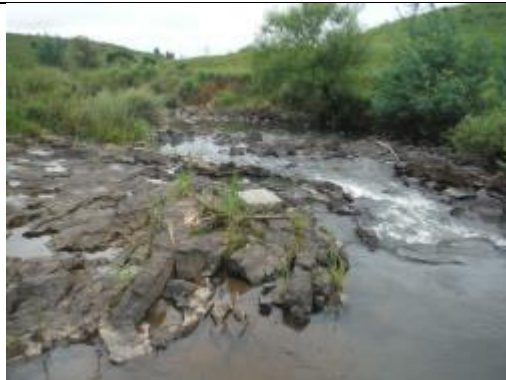
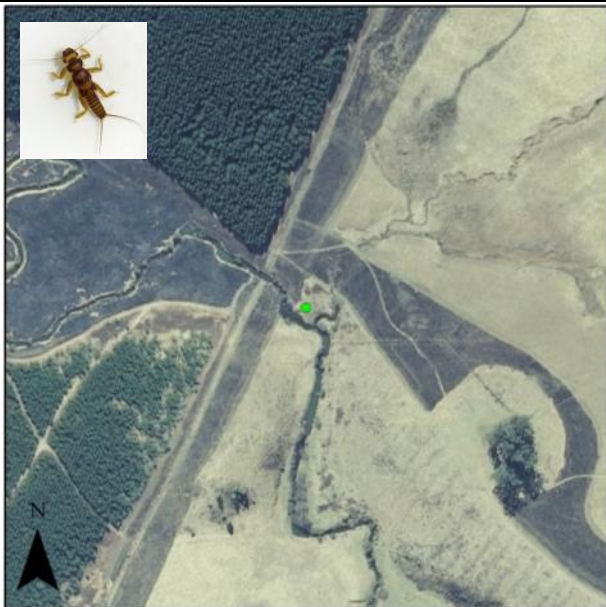
Upstream view from sample site		Downstream view from sample site	
Day 3	Site 16	Water Management Area	uMvoti to uMzimkhulu
River	Karkloof	1:50000 map reference	2930AC
Quaternary Catchment	U20D	Aquatic Ecoregion	South eastern Uplands
Latitude (S) DD	-29.33380

Longitude (E) DD	30.21450		
Aquatic Assessments			
MiniSASS			
Total score	57		
No. Groups	8		
Average score	7,13		
Condition	Good		
RHA			
Score	9.5		
% transformed	23.75		
Condition	Good		
In situ and chemical water quality		Clarity (cm)	47
Temperature (°C)	14.23	pH	4.59
Dissolved oxygen %	99.2	<i>E. coli</i> (mpn/100ml)	76
Electrical Conductivity (mS/m)	8.9	Nitrate (mg/l)	<0.18
Total dissolved salts (mg/l)	34	Orthophosphate(mg/l)	<0.03
Description: The site is between plantation plots and farms. The miniSASS results showed the site to be of good health. This was the second site where the sensitive stonefly (<i>Perlidae sp.</i>) was found. The river had passed through sections with good instream habitat and the RHA results also indicated good habitat conditions. However, the riparian areas were badly impacted by invasive alien plants, mostly bramble (<i>Rubus cuneifolius</i>), in the research plantation plots. The water chemistry results were within acceptable ranges, with the exception of pH which was found more acidic than the recommended range. The pH was only marginally more acidic than the recommended range and the increased acidity is likely related to increased humic acid from decomposing vegetation.

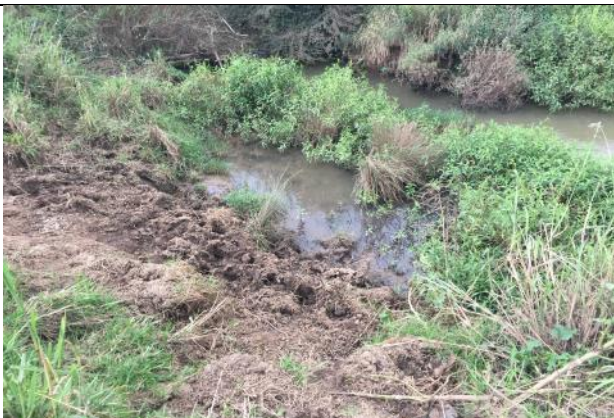
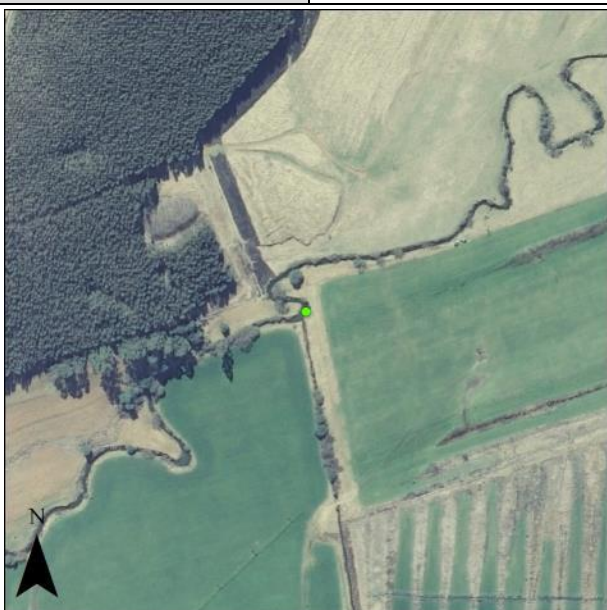
Upstream view from sample site			
Day 3	Site 17	Water Management Area	uMvoti to uMzimkhulu
River	Karkloof	1:50000 map reference	2930AC
Quaternary Catchment	U20D	Aquatic Ecoregion	South eastern Uplands
Latitude (S) DD	-29.34040

Longitude (E) DD	30.22590		
Aquatic Assessments			
MiniSASS			
Total score	ns		
No. Groups	ns		
Average score	ns		
Condition	ns		
RHA			
Score	ns		
% transformed	ns		
Condition	ns		
In situ and chemical water quality		Clarity (cm)	ns
Temperature (°C)	ns	pH	ns
Dissolved oxygen %	ns	<i>E. coli</i> (mpn/100ml)	120
Electrical Conductivity (mS/m)	ns	Nitrate (mg/l)	<0.18
Total dissolved salts (mg/l)	ns	Orthophosphate(mg/l)	<0.03
Description: The site is located next to agricultural land and is near a pump house, above the site there were cattle tracks on the bank of the river and this reach is accessed directly by cattle for drinking purposes. At this point the river had gone through a stretch of knot weed (<i>Persicaria lapathifolia</i>) vegetation. Only a water sample was collected at the site.

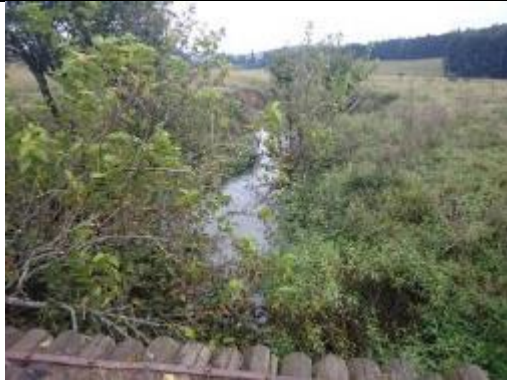
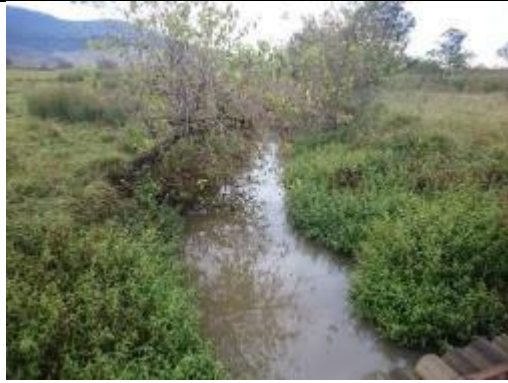
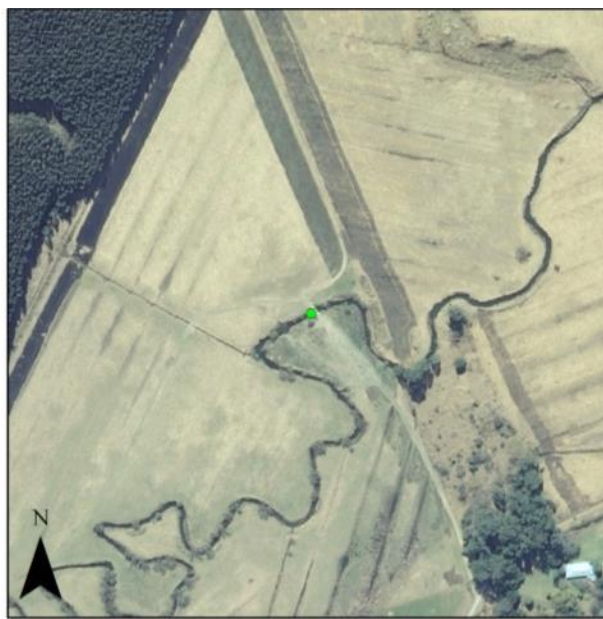
Upstream view from sample site		Downstream view from sample site	
Day 4	Site 18	Water Management Area	uMvoti to uMzimkhulu
River	Karkloof	1:50000 map reference	2930AC
Quaternary Catchment	U20D	Aquatic Ecoregion	South eastern Uplands
Latitude (S) DD	-29.33580

Longitude (E) DD	30.23060		
Aquatic Assessments			
MiniSASS			
Total score	ns		
No. Groups	ns		
Average score	ns		
Condition	ns		
RHA			
Score	5		
% transformed	12.5		
Condition	Good		
In situ and chemical water quality		Clarity (cm)	ns
Temperature (°C)	ns	pH	ns
Dissolved oxygen %	ns	E. coli (mpn/100ml)	88
Electrical Conductivity (mS/m)	ns	Nitrate (mg/l)	0.2
Total dissolved salts (mg/l)	ns	Orthophosphate(mg/l)	<0.03
Description: This site was located on the river after traversing approximately 4km of farmlands. The flow velocity had decreased and the river was deeper, as a result the site was not suitable for SASS5. The RHA found the site to be in a generally good condition with only some physical disturbance from cattle, minor water abstraction and a few exotic plants impacting this reach.

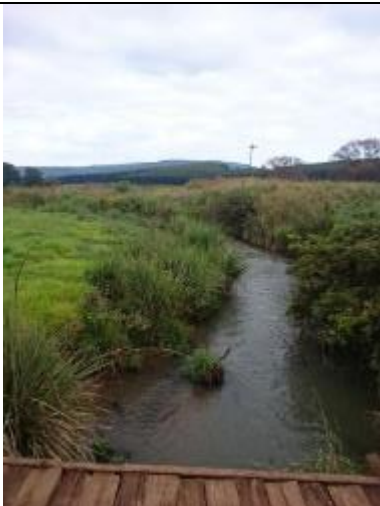
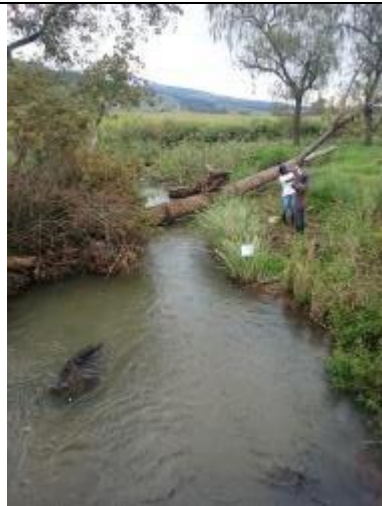
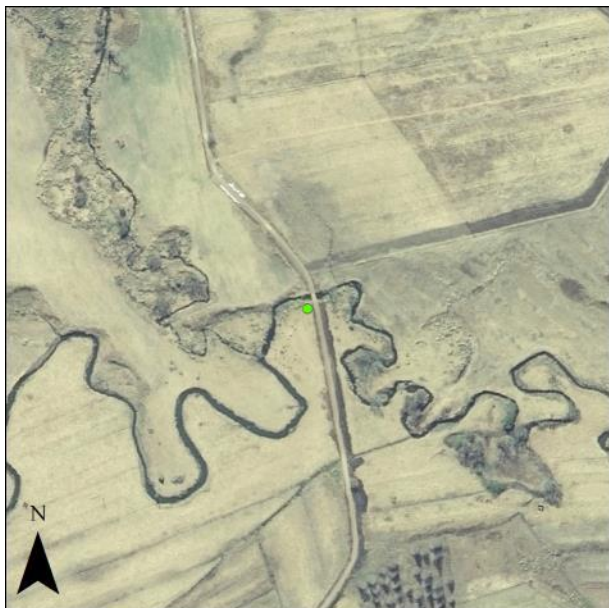
Upstream view from sample site		Downstream view from sample site	
Day 4	Site 19	Water Management Area	uMvoti to uMzimkhulu
River	Karkloof	1:50000 map reference	2930AC
Quaternary Catchment	U20D	Aquatic Ecoregion	South eastern Uplands
Latitude (S) DD	-29.333708

Longitude (E) DD	30.235243		
Aquatic Assessments			
MiniSASS			
Total score	63		
No. Groups	9		
Average score	7		
Condition	Good		
RHA			
Score	ns		
% transformed	ns		
Condition	ns		
In situ and chemical water quality		Clarity (cm)	48
Temperature (°C)	17.20	pH	6.88
Dissolved oxygen %	66.9	<i>E. coli</i> (mpn/100ml)	ns
Electrical Conductivity (mS/m)	6.6	Nitrate (mg/l)	ns
Total dissolved salts (mg/l)		Orthophosphate(mg/l)	ns
Description: The site was a few kilometres downstream from site 18 and provided habitat for miniSASS sampling. The riparian condition was similar to that recoded at site 18. The water velocity had increased and the miniSASS results showed the site to be in a good condition. This was the third site where the sensitive stonefly (<i>Perlidae sp.</i>) was found. The water chemistry results were in acceptable ranges. Downstream of this point the land use began to change.

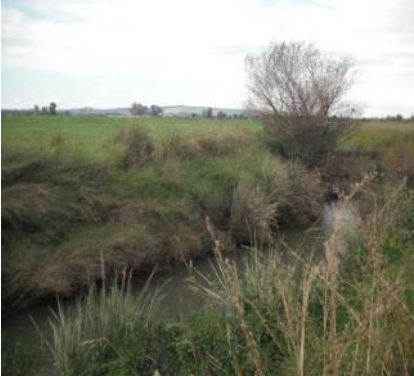
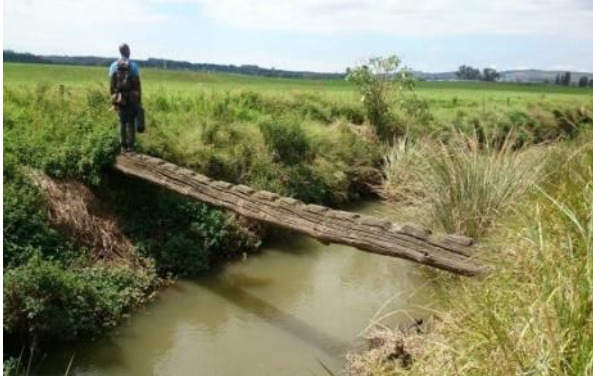
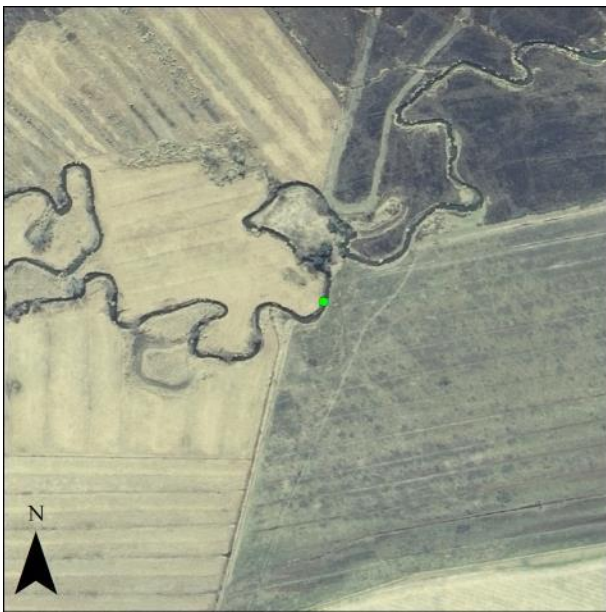
Upstream view from sample site		Downstream view from sample site	
Day 4	Site 20	Water Management Area	uMvoti to uMzimkhulu
River	Karkloof	1:50000 map reference	2930AC
Quaternary Catchment	U20D	Aquatic Ecoregion	South eastern Uplands
Latitude (S) DD	-29.33130

Longitude (E) DD	30.24560		
Aquatic Assessments			
MiniSASS			
Total score	ns		
No. Groups	ns		
Average score	ns		
Condition	ns		
RHA			
Score	4.5		
% transformed	11.25		
Condition	Good		
In situ and chemical water quality		Clarity (cm)	ns
Temperature (°C)	ns	pH	ns
Dissolved oxygen %	ns	<i>E. coli</i> (mpn/100ml)	ns
Electrical Conductivity (mS/m)	ns	Nitrate (mg/l)	ns
Total dissolved salts (mg/l)	ns	Orthophosphate(mg/l)	ns
Description: The site was located near a pump house and feedlot. The Riparian Habitat Assessment result indicated the site was in a good condition. The riparian zones were however impacted by invasive alien plants, most notably Bugweed (<i>Solanum mauritianum</i>). The form of agriculture changed to predominantly livestock farming along this reach.

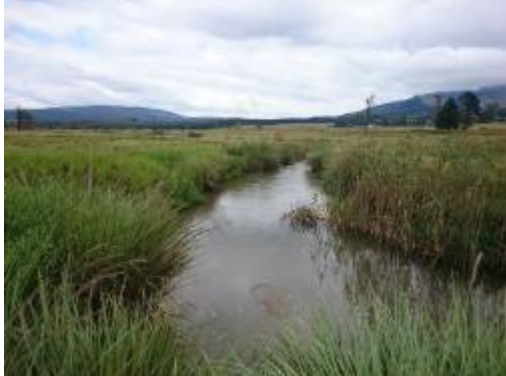
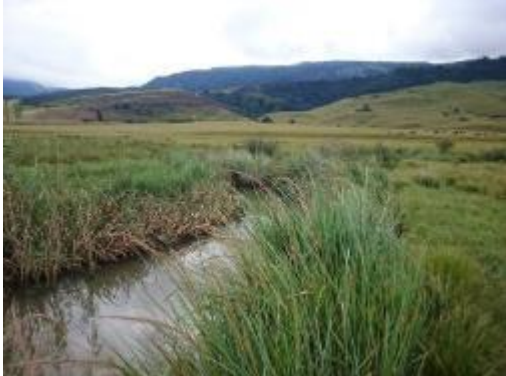
Upstream view from sample site		Downstream view from sample site	
Day 4	Site 21	Water Management Area	uMvoti to uMzimkhulu
River	Karkloof	1:50000 map reference	2930AC
Quaternary Catchment	U20D	Aquatic Ecoregion	South eastern Uplands
Latitude (S) DD	-29.331256		
Longitude (E) DD	30.245622		
Aquatic Assessments			
MiniSASS			
Total score	ns		
No. Groups	ns		
Average score	ns		
Condition	ns		
RHA			
Score	ns		
% transformed	ns		
Condition	ns		
In situ and chemical water quality		Clarity (cm)	50
Temperature (°C)	17.67	pH	6.92
Dissolved oxygen %	74.3	<i>E. coli</i> (mpn/100ml)	64
Electrical Conductivity (mS/m)	6.4	Nitrate (mg/l)	0.22
Total dissolved salts (mg/l)		Orthophosphate(mg/l)	<0.03
Description: The flows had once again slowed down and the water was deeper at this site. The reach was surrounded by good quality grassland vegetation and there was livestock in the vicinity but in limited numbers. Water chemistry was the only assessment done at the site and the results were within the target ranges, albeit that <i>E. coli</i> was too high for domestic use.

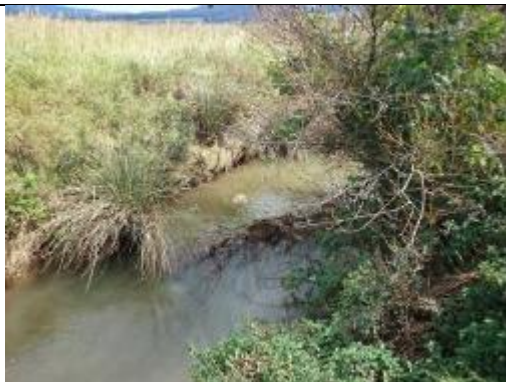
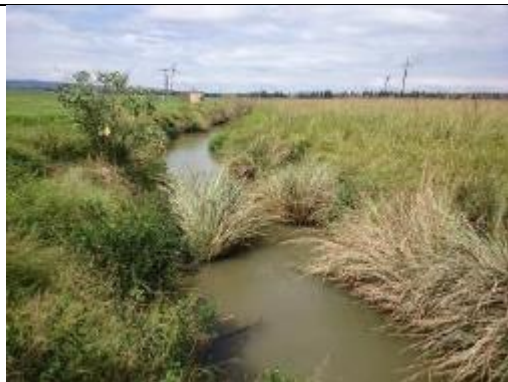
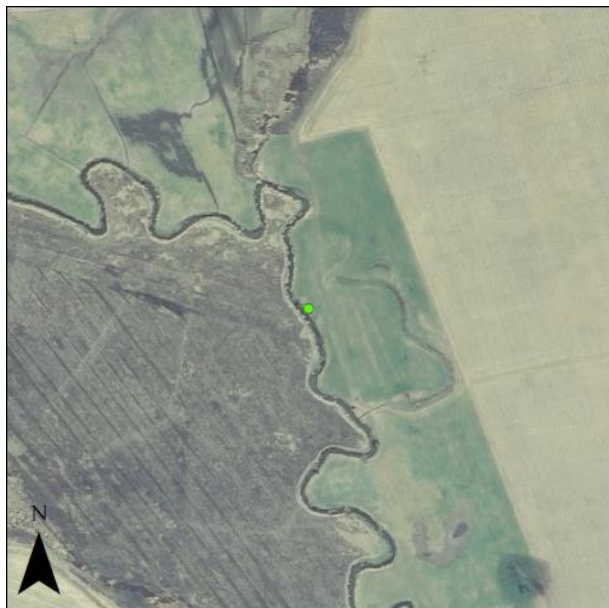
Upstream view from sample site		Downstream view from sample site	
Day 4	Site 22	Water Management Area	uMvoti to uMzimkhulu
River	Karkloof	1:50000 map reference	2930AD
Quaternary Catchment	U20D	Aquatic Ecoregion	South eastern Uplands
Latitude (S) DD	-29.33550

Longitude (E) DD	30.25670		
Aquatic Assessments			
MiniSASS			
Total score	ns		
No. Groups	ns		
Average score	ns		
Condition	ns		
RHA			
Score	ns		
% transformed	ns		
Condition	ns		
In situ and chemical water quality		Clarity (cm)	41
Temperature (°C)	18.14	pH	7.04
Dissolved oxygen %	80.4	<i>E. coli</i> (mpn/100ml)	340
Electrical Conductivity (mS/m)	6.2	Nitrate (mg/l)	0.42
Total dissolved salts (mg/l)	31	Orthophosphate(mg/l)	<0.03
Description: The site was located below and a piggery cattle feedlot. The water chemistry results were in an acceptable range except for <i>E. coli</i> which had increased notably. This increase is likely related to impacts from the livestock operations upstream.

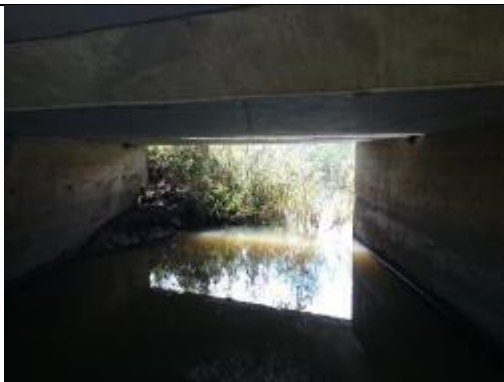
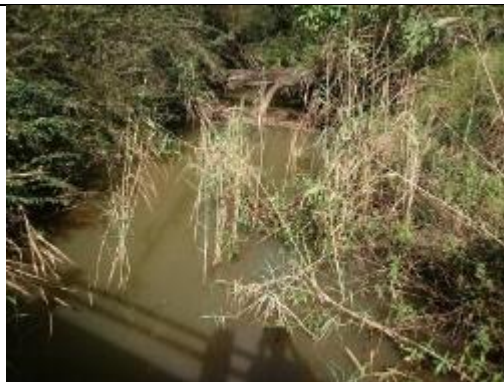
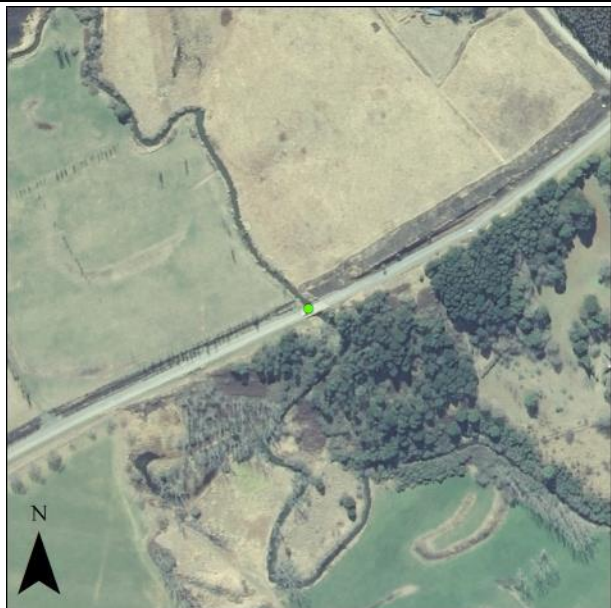
Upstream view from sample site		Downstream view from sample site	
Day 4	Site 23	Water Management Area	uMvoti to uMzimkhulu
River	Karkloof	1:50000 map reference	2930AD
Quaternary Catchment	U20D	Aquatic Ecoregion	South eastern Uplands
Latitude (S) DD	-29.33960

Longitude (E) DD	30.27210		
Aquatic Assessments			
MiniSASS			
Total score	22		
No. Groups	5		
Average score	4.4		
Condition	Very poor		
RHA			
Score	14.5		
% transformed	36.25		
Condition	Fair		
In situ and chemical water quality		Clarity (cm)	47
Temperature (°C)	18.88	pH	6.59
Dissolved oxygen %	75.5	E. coli (mpn/100ml)	ns
Electrical Conductivity (mS/m)	6.4	Nitrate (mg/l)	ns
Total dissolved salts (mg/l)		Orthophosphate(mg/l)	ns
Description: The site is below the bridge on the Karkloof road. The miniSASS results indicated the health at the site was very poor. There was a decline in the instream habitat and macroinvertebrate community, this is likely related to impacts from the dumping tar/asphalt associated with road repairs being pushed/dumped into the river and from irrigation of slurry onto lands closer than 100m from the river. The riparian habitat was in fair condition, with the river passing through an extensive patch of <i>Phragmites</i> reeds.

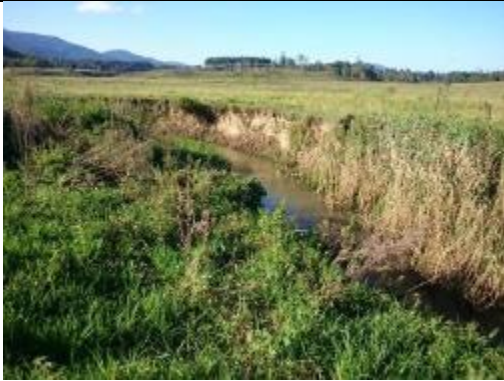
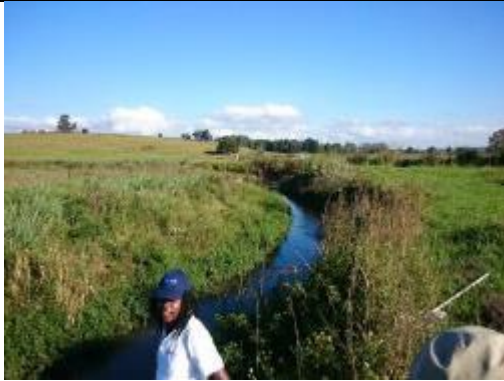
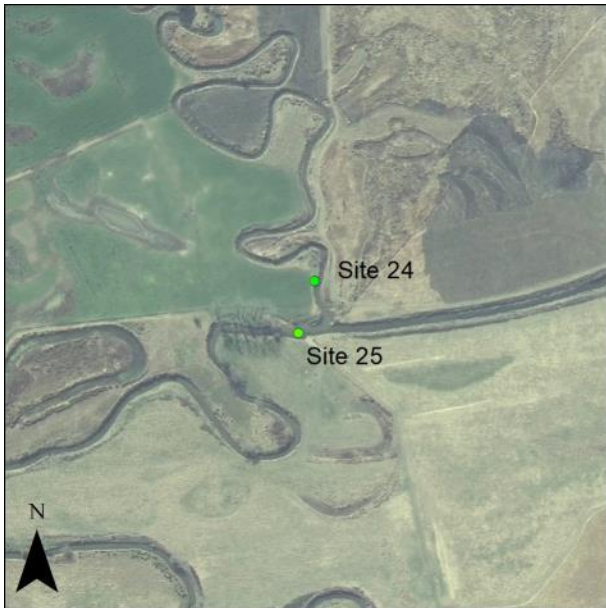
Upstream view from sample site		Downstream view from sample site	
Day 4	Site 24	Water Management Area	uMvoti to uMzimkhulu
River	Karkloof	1:50000 map reference	2930AD
Quaternary Catchment	U20D	Aquatic Ecoregion	South eastern Uplands
Latitude (S) DD	-29.34780

Longitude (E) DD	30.28630		
Aquatic Assessments			
MiniSASS			
Total score	ns		
No. Groups	ns		
Average score	ns		
Condition	ns		
RHA			
Score	ns		
% transformed	ns		
Condition	ns		
In situ and chemical water quality		Clarity (cm)	42
Temperature (°C)	19.01	pH	6.81
Dissolved oxygen %	76.5	<i>E. coli</i> (mpn/100ml)	122
Electrical Conductivity (mS/m)	6.6	Nitrate (mg/l)	0.42
Total dissolved salts (mg/l)		Orthophosphate(mg/l)	<0.03
Description: This site is located on the Karkloof River approximately 20 metres upstream of the Yarrow River confluence. Only water chemistry was collected and other than slightly elevate <i>E. coli</i> levels the water quality was within acceptable ranges.
