KARKLOOF RIVER WALK AQUATIC AND RIPARIAN ASSESSMENT

FINAL REPORT

26 - 31 March 2017

Project: GT0835

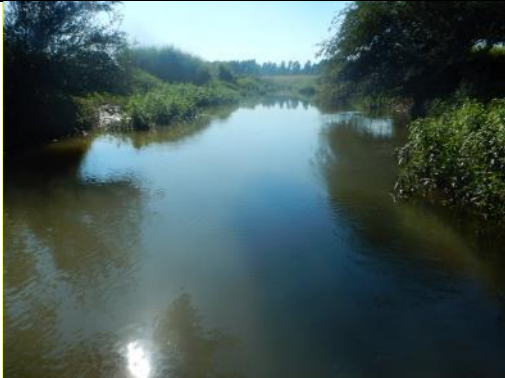
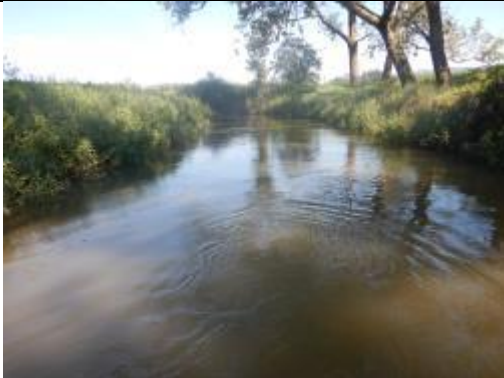
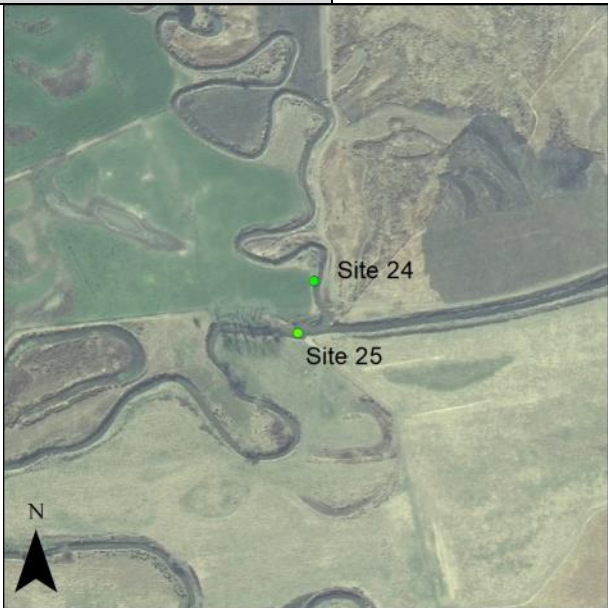
Upstream view from sample site		Downstream view from sample site	
Day 4	Site 25	Water Management Area	uMvoti to uMzimkhulu
River	Karkloof	1:50000 map reference	2930AD
Quaternary Catchment	U20D	Aquatic Ecoregion	South eastern Uplands
Latitude (S) DD	-29.348258

Longitude (E) DD	30.285908		
Aquatic Assessments			
MiniSASS			
Total score	ns		
No. Groups	ns		
Average score	ns		
Condition	ns		
RHA			
Score	ns		
% transformed	ns		
Condition	ns		
In situ and chemical water quality		Clarity (cm)	ns
Temperature (°C)	ns	pH	ns
Dissolved oxygen %	ns	<i>E. coli</i> (mpn/100ml)	218
Electrical Conductivity (mS/m)	ns	Nitrate (mg/l)	0.52
Total dissolved salts (mg/l)	ns	Orthophosphate(mg/l)	<0.03
Description: This site is on the Karkloof shortly after the confluence with the Yarrow River, which significantly increased the volume of water. Only a water chemistry sample was collected at the site, the nitrate and <i>E. coli</i> were slightly elevated indicating the possible influence of livestock entering from the Yarrow.

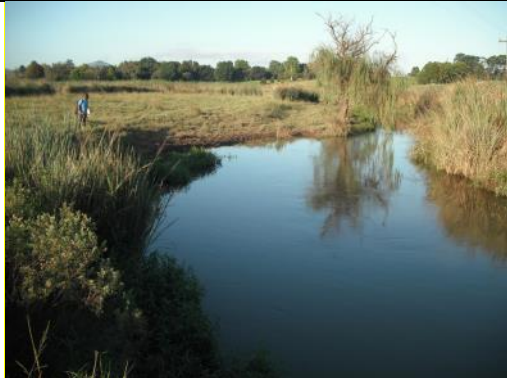
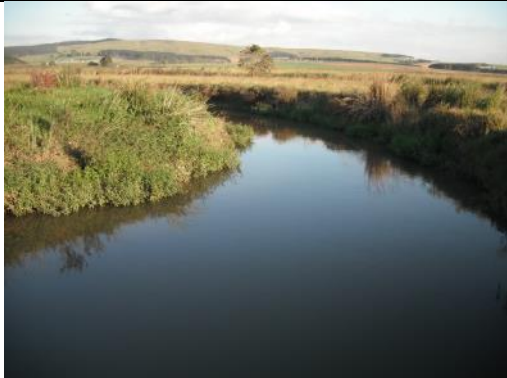
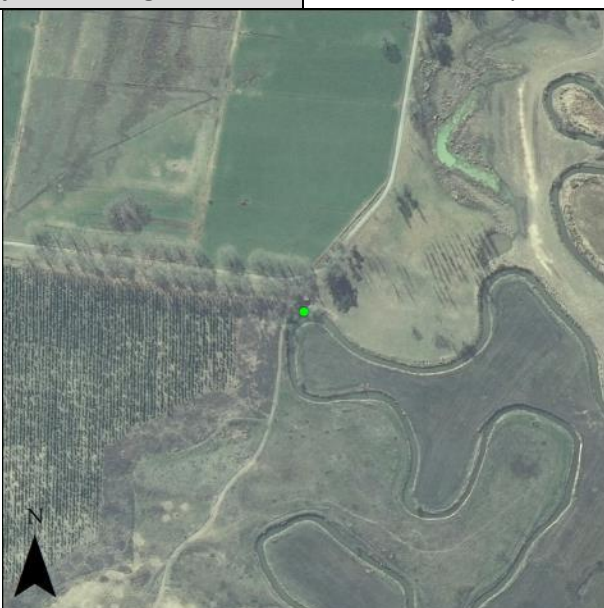
Upstream view from sample site		Downstream view from sample site	
Day 4	Site 26	Water Management Area	uMvoti to uMzimkhulu
River	Karkloof	1:50000 map reference	2930AD
Quaternary Catchment	U20D	Aquatic Ecoregion	South eastern Uplands
Latitude (S) DD	-29.350382

Longitude (E) DD	30.283161		
Aquatic Assessments			
MiniSASS			
Total score	ns		
No. Groups	ns		
Average score	ns		
Condition	ns		
RHA			
Score	9.5		
% transformed	23.75		
Condition	Good		
In situ and chemical water quality		Clarity (cm)	32
Temperature (°C)	19.78	pH	6.91
Dissolved oxygen %	94.5	<i>E. coli</i> (mpn/100ml)	190
Electrical Conductivity (mS/m)	5.9	Nitrate (mg/l)	0.46
Total dissolved salts (mg/l)	29	Orthophosphate(mg/l)	<0.03
Description: This site is upstream of a plantation and downstream of a pump house. The river was wide and deep at this point making it unsuitable for miniSASS. The RHA indicated that this reach was generally in a good condition, with some degraded vegetation and cattle trampling being the main riparian impacts.

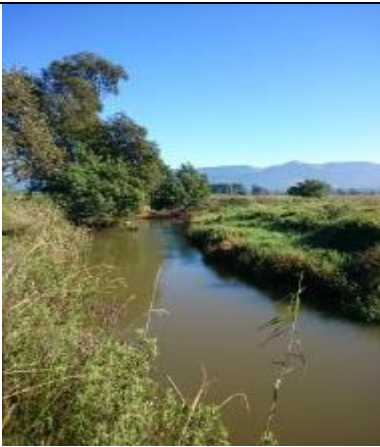
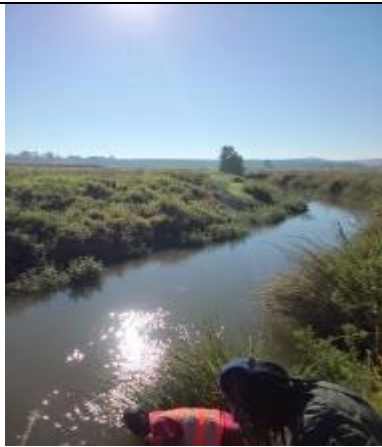
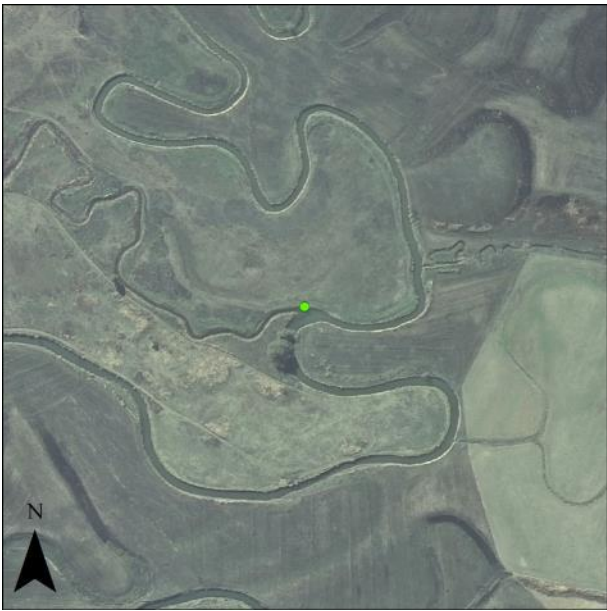
Upstream view from sample site		Downstream view from sample site	
Day 5	Site 27	Water Management Area	uMvoti to uMzimkhulu
River	Karkloof	1:50000 map reference	2930AD
Quaternary Catchment	U20D	Aquatic Ecoregion	South eastern Uplands
Latitude (S) DD	-29.363751

Longitude (E) DD	30.280588		
Aquatic Assessments			
MiniSASS			
Total score	ns		
No. Groups	ns		
Average score	ns		
Condition	ns		
RHA			
Score	10.5		
% transformed	26.25		
Condition	Good		
In situ and chemical water quality		Clarity (cm)	37
Temperature (°C)	17.49	pH	7.0
Dissolved oxygen %	70.8	<i>E. coli</i> (mpn/100ml)	ns
Electrical Conductivity (mS/m)	6.2	Nitrate (mg/l)	ns
Total dissolved salts (mg/l)	31	Orthophosphate(mg/l)	ns
Description: The site was located on land historically planted to timber in a wetland section, now in the process of being rehabilitated, where the water was deep and the banks slightly incised. The site was upstream of the Kusane confluence. The RHA results indicated the reach was in a good condition, but the site was largely impacted by bramble (<i>Rubus cuneifolius</i>) and Knot weed (<i>Persicaria lapathifolia</i>). Water chemistry results fell within acceptable ranges.

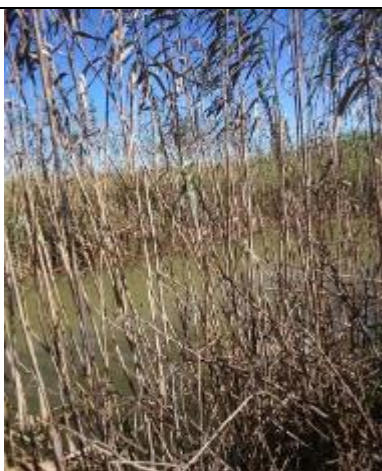
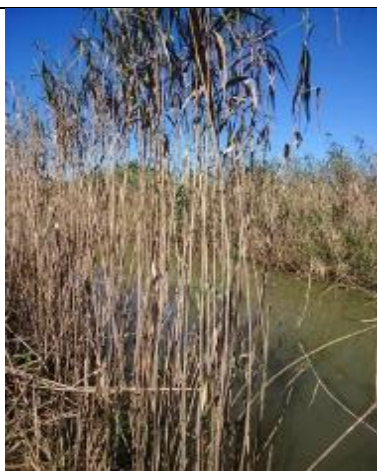
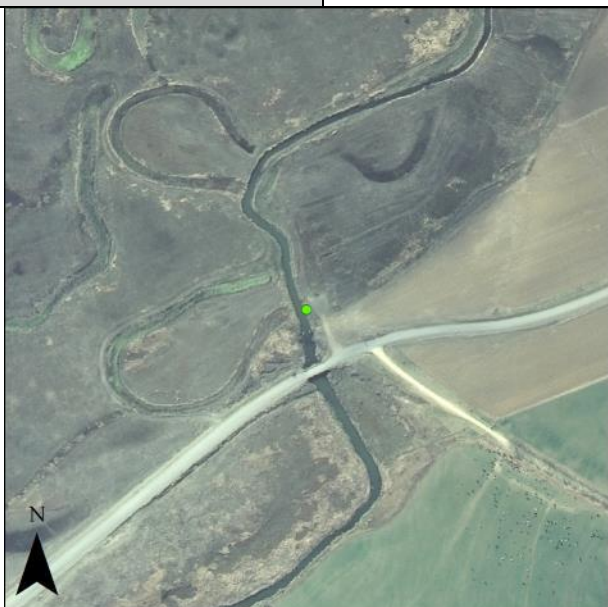
Upstream view from sample site		Downstream view from sample site	
Day 5	Site 28	Water Management Area	uMvoti to uMzimkhulu
River	Karkloof	1:50000 map reference	2930AD
Quaternary Catchment	U20D	Aquatic Ecoregion	South eastern Uplands
Latitude (S) DD	-29.37710

Longitude (E) DD	30.27930		
Aquatic Assessments			
MiniSASS			
Total score	ns		
No. Groups	ns		
Average score	ns		
Condition	ns		
RHA			
Score	6.5		
% transformed	16.25		
Condition	Good		
In situ and chemical water quality		Clarity (cm)	40
Temperature (°C)	18.01	pH	6.83
Dissolved oxygen %	76.7	E. coli (mpn/100ml)	10000
Electrical Conductivity (mS/m)	6.4	Nitrate (mg/l)	0.42
Total dissolved salts (mg/l)	34	Orthophosphate(mg/l)	<0.03
Description: The site is approximately 10 meters upstream of Karkloof bridge on the Crammond road. The river had passed through approximately 5km of degraded wetland between site27 and site 28. This was the first site with very high E. coli counts. There is a tributary that joins the Karkloof between sites 27 and 28, which may have contributed to the higher E. coli counts. The RHA results indicate the site to be in a good condition; however the site had large areas of Common Reed (<i>Phragmites australis</i>) which can indicate degradation. In certain sections extensive bramble (<i>R. cuneifolius</i>) coverage was a concern.

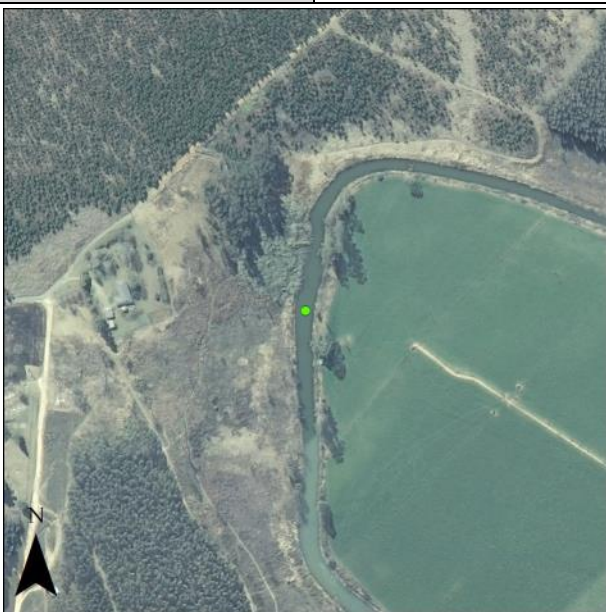
Upstream view from sample site		Downstream view from sample site	
Day 5	Site 29	Water Management Area	uMvoti to uMzimkhulu
River	Karkloof	1:50000 map reference	2930AD
Quaternary Catchment	U20E	Aquatic Ecoregion	South eastern Uplands
Latitude (S) DD	-29.38499

Longitude (E) DD	30.27229		
Aquatic Assessments			
MiniSASS			
Total score	ns		
No. Groups	ns		
Average score	ns		
Condition	ns		
RHA			
Score	ns		
% transformed	ns		
Condition	ns		
In situ and chemical water quality		Clarity (cm)	ns
Temperature (°C)	ns	pH	ns
Dissolved oxygen %	ns	<i>E. coli</i> (mpn/100ml)	2300
Electrical Conductivity (mS/m)	ns	Nitrate (mg/l)	0.5
Total dissolved salts (mg/l)	ns	Orthophosphate(mg/l)	0.044
Description: The river was approximately 12 metres wide and more than half a metre deep at this site. The flatter topography and wider river resulted in slower flows. Maize was being grown in the reach upstream. Only water chemistry samples were collected at this site and these showed an increase in nitrate and orthophosphate. These nutrients are normally related to fertilizers.

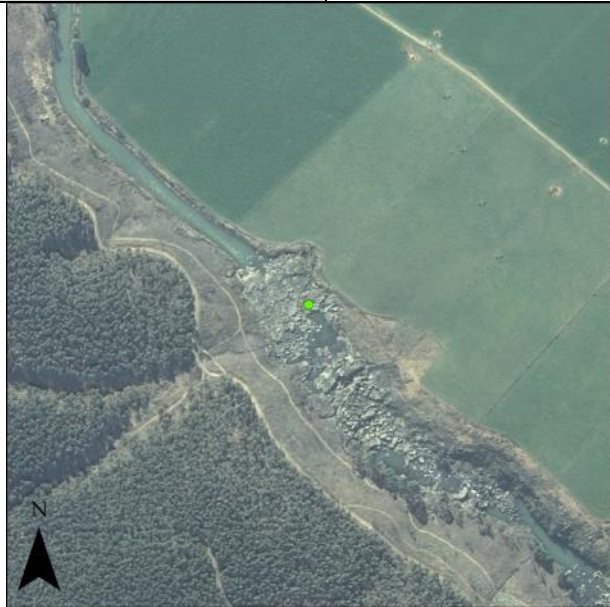
Upstream view from sample site		Downstream view from sample site	
Day 5	Site 30	Water Management Area	uMvoti to uMzimkhulu
River	Karkloof	1:50000 map reference	2930AD
Quaternary Catchment	U20E	Aquatic Ecoregion	South eastern Uplands
Latitude (S) DD	-29.38940

Longitude (E) DD	30.27420		
Aquatic Assessments			
MiniSASS			
Total score	22		
No. Groups	5		
Average score	4.4		
Condition	Very poor		
RHA			
Score	13.5		
% transformed	33.75		
Condition	Fair		
In situ and chemical water quality		Clarity (cm)	48
Temperature (°C)	18.58	pH	6.64
Dissolved oxygen %	79.1	<i>E. coli</i> (mpn/100ml)	300
Electrical Conductivity (mS/m)	6.3	Nitrate (mg/l)	0.5
Total dissolved salts (mg/l)	32	Orthophosphate(mg/l)	<0.03
Description: Located at the first bed rocks site before Karkloof Falls – Water quality looked poor, there was a dead bush buck (death due to natural causes) in the water, The riparian are was impacted by exotics such as Bamboo (<i>Bambusa sp.</i>), gum (<i>Eucalyptus sp.</i>), bramble (<i>Rubus cuneifolius</i>) and elderflower (<i>Sambucus sp.</i>) and the adjacent agriculture extended into the riparian zone in several places these impacts were the cause of the fair condition in the riparian zone. The site was shallower than the previous site but wider (up to 20m). Habitat was available for miniSASS (the only site where miniSASS was possible for day five) but habitat was limited. The limited habitat and poorer water quality are the likely causes of the very poor condition scored by the miniSASS assessment. Nitrate was at the maximum target value and <i>E. coli</i> exceeded the recommended range for domestic and irrigation usage.

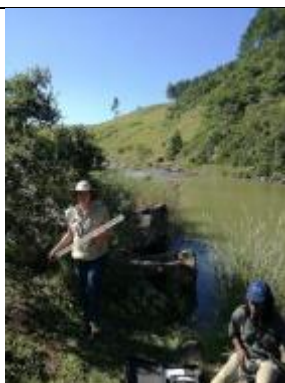
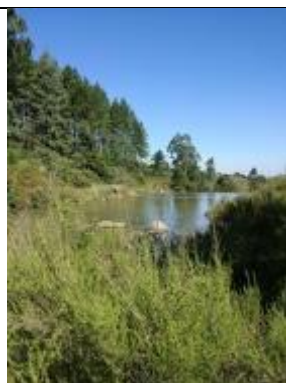
Upstream view from sample site		Downstream view from sample site	
Day 5	Site 31	Water Management Area	uMvoti to uMzimkhulu
River	Karkloof	1:50000 map reference	2930AD
Quaternary Catchment	U20E	Aquatic Ecoregion	South Eastern Uplands
Latitude (S) DD	-29.39460		
Longitude (E) DD	30.27970		
Aquatic Assessments			
MiniSASS			
Total score	ns		
No. Groups	ns		
Average score	ns		
Condition	ns		
RHA			
Score	10.5		
% transformed	26.25		
Condition	Good		
In situ and chemical water quality		Clarity (cm)	48
Temperature (°C)	19.9	pH	7.35
Dissolved oxygen %	93.7	<i>E. coli</i> (mpn/100ml)	220
Electrical Conductivity (mS/m)	6.3	Nitrate (mg/l)	0.51
Total dissolved salts (mg/l)	32	Orthophosphate(mg/l)	<0.03
Description: The last site before the first Karkloof waterfall. The site has a deep, slow flowing pool. Rubbish was the largest riparian impact as the site is used as a recreational park. The water quality, as with the previous sites, had elevated <i>E. coli</i> and nitrates when compared to the sites sampled on earlier days of the walk. The RHA assessment indicated that the site was in a good condition despite the rubbish and maintained lawns in the riparian area. The water chemistry result was within acceptable ranges except for <i>E. coli</i> . and borderline nitrates.

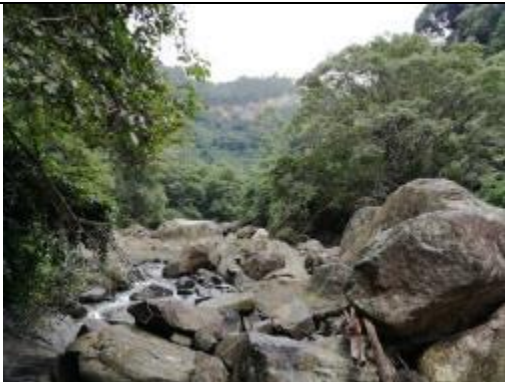
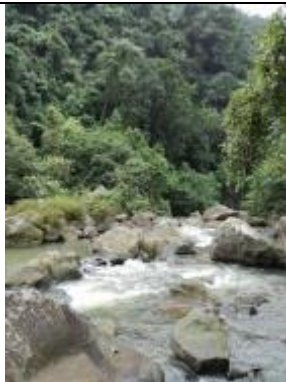
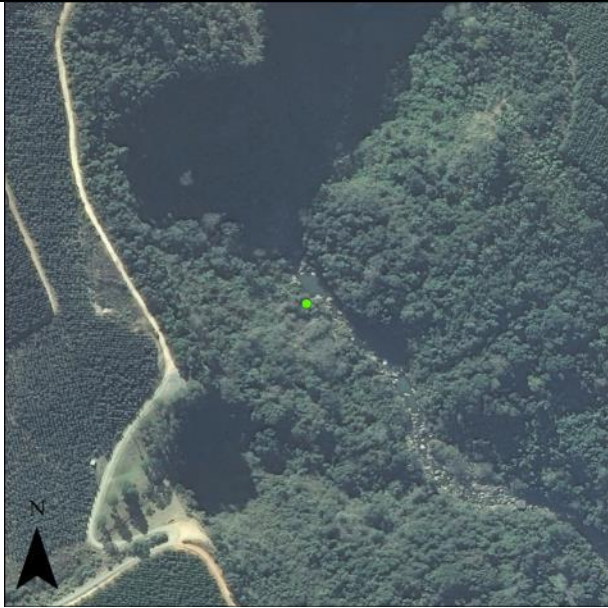
Upstream view from sample site		Downstream view from sample site	
Day 6	Site 32	Water Management Area	uMvoti to uMzimkhulu
River	Karkloof	1:50000 map reference	2930AD
Quaternary Catchment	U20E	Aquatic Ecoregion	South Eastern Uplands
Latitude (S) DD	-29.40350

Longitude (E) DD	30.27810		
Aquatic Assessments			
MiniSASS			
Total score	ns		
No. Groups	ns		
Average score	ns		
Condition	ns		
RHA			
Score	ns		
% transformed	ns		
Condition	ns		
In situ and chemical water quality		Clarity (cm)	63
Temperature (°C)	18.81	pH	7.42
Dissolved oxygen %	81.1	<i>E. coli</i> (mpn/100ml)	310
Electrical Conductivity (mS/m)	7.0	Nitrate (mg/l)	0.66
Total dissolved salts (mg/l)	35	Orthophosphate(mg/l)	0.034
Description: Site 32 was located below falls along the boardwalk and was the closest accessible site downstream of the falls. This section of the river predominantly flows around large boulders. The site is in a valley where the river banks are steep and well covered with dense indigenous vegetation. The nutrients, nitrate and orthophosphate were marginally higher than seen at site 31. <i>E. coli</i> was still higher than the recommended target range for domestic use and irrigation.

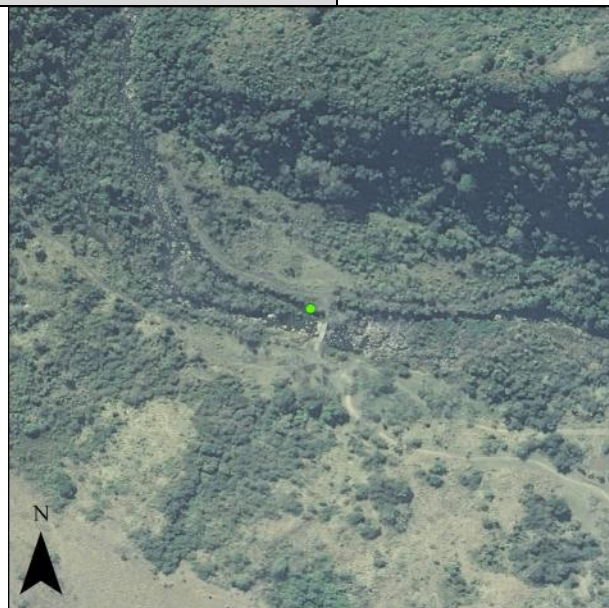
Upstream view from sample site		Downstream view from sample site	
Day 6	Site 33	Water Management Area	uMvoti to uMzimkhulu
River	Karkloof	1:50000 map reference	2930ACD
Quaternary Catchment	U20E	Aquatic Ecoregion	South eastern Uplands
Latitude (S) DD	-29.41600

Longitude (E) DD	30.27670		
Aquatic Assessments			
MiniSASS			
Total score	44		
No. Groups	7		
Average score	6.3		
Condition	Good		
RHA			
Score	2.5		
% transformed	6.25		
Condition	Natural		
In situ and chemical water quality		Clarity (cm)	63
Temperature (°C)	19.43	pH	7.36
Dissolved oxygen %	77.0	<i>E. coli</i> (mpn/100ml)	168
Electrical Conductivity (mS/m)	7.0	Nitrate (mg/l)	0.65
Total dissolved salts (mg/l)	35	Orthophosphate(mg/l)	<0.03
Description: At the spa road crossing, the site is immediately upstream of the bridge. It was an extremely rocky river bed. The site is on the outer edge of a large indigenous forest. Both the miniSASS and RHA results showed an improvement for the day five site results, indicating an improvement in the system. Water quality was good, with only nitrates and <i>E. coli</i> falling outside of recommended target water quality ranges.

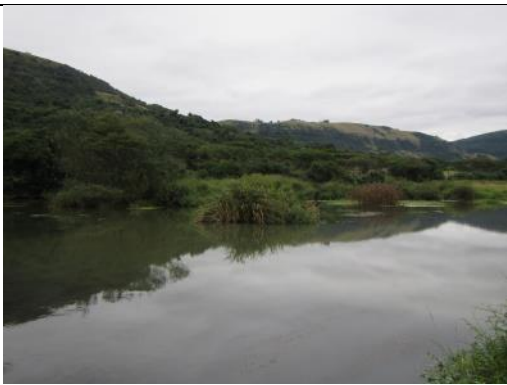
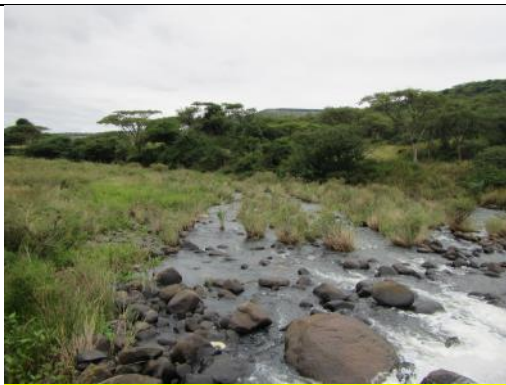
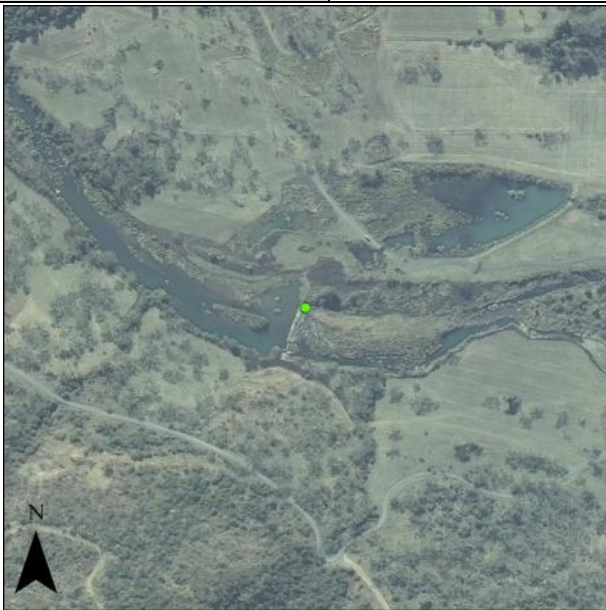
Upstream view from sample site		Downstream view from sample site	
Day 6	Site 34	Water Management Area	uMvoti to uMzimkhulu
River	Karkloof	1:50000 map reference	2930AD
Quaternary Catchment	U20E	Aquatic Ecoregion	South eastern Uplands
Latitude (S) DD	-29.44220		
Longitude (E) DD	30.30540		
Aquatic Assessments

MiniSASS			
Total score	ns		
No. Groups	ns		
Average score	ns		
Condition	ns		
RHA			
Score	ns		
% transformed	ns		
Condition	ns		
In situ and chemical water quality		Clarity (cm)	56
Temperature (°C)	20.34	pH	7.14
Dissolved oxygen %	89.4	<i>E. coli</i> (mpn/100ml)	36
Electrical Conductivity (mS/m)	7.0	Nitrate (mg/l)	0.46
Total dissolved salts (mg/l)	35	Orthophosphate(mg/l)	<0.03
Description: At a weir, the river bed is partially made up of artificial substrate both upstream and downstream of the weir. The water was pooled and slow-flowing upstream of the weir. Thick reed beds (<i>Phragmites</i>) were present downstream of the weir. The water quality parameters had improved from this point with only <i>E. coli</i> being marginally higher than the recommended domestic and irrigation target ranges.

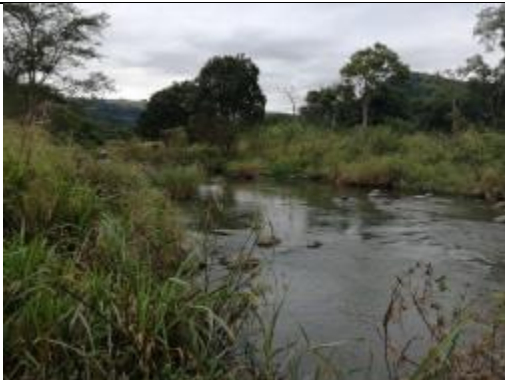
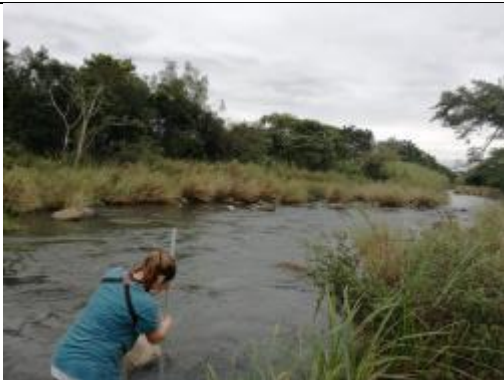
Upstream view from sample site		Downstream view from sample site	
Day 6	Site 35	Water Management Area	uMvoti to uMzimkhulu
River	Karkloof	1:50000 map reference	2930AD
Quaternary Catchment	U20E	Aquatic Ecoregion	South eastern Uplands
Latitude (S) DD	-29.44430		
Longitude (E) DD	30.31560		
Aquatic Assessments			
MiniSASS			
Total score	38		
No. Groups	6		
Average score	6.3		
Condition	Good		
RHA			
Score	ns		
% transformed	ns		
Condition	ns		
In situ and chemical water quality		Clarity (cm)	59
Temperature (°C)	20.61	pH	7.30
Dissolved oxygen %	89.7	<i>E. coli</i> (mpn/100ml)	74
Electrical Conductivity (mS/m)	7.0	Nitrate (mg/l)	0.44
Total dissolved salts (mg/l)	35	Orthophosphate(mg/l)	0.149
Description: Hippo entry site, the site is at a wide section of the river. Mostly a sandy river bed. Open grassland on the one side of the river and thicker indigenous bush on the opposite side. The miniSASS results show the site to be in a good condition. Water quality was in the acceptable range except for <i>E. coli</i> . Orthophosphate was the highest recorded of all the sites. The slightly higher orthophosphate and <i>E. coli</i> are likely the result of the site being utilized by hippo.

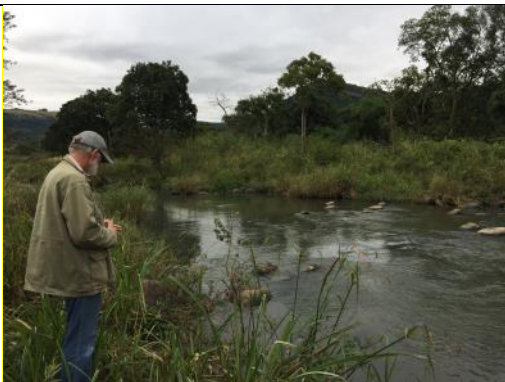
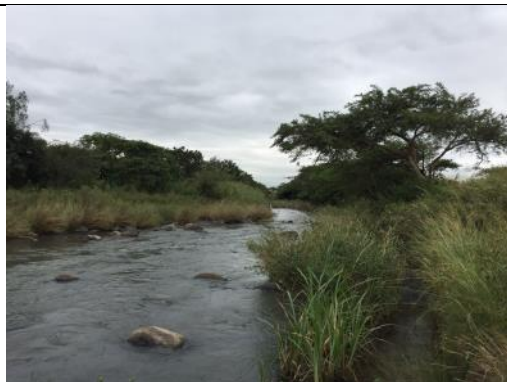
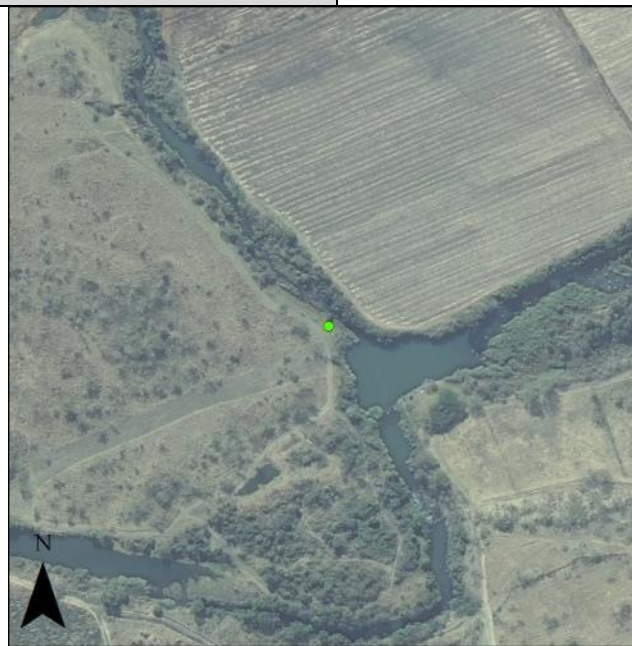
Upstream view from sample site		Downstream view from sample site	
Day 6	Site 36	Water Management Area	uMvoti to uMzimkhulu
River	Karkloof	1:50000 map reference	2930AD
Quaternary Catchment	U20E	Aquatic Ecoregion	South eastern Uplands
Latitude (S) DD	-29.445894

Longitude (E) DD	30.320927		
Aquatic Assessments			
MiniSASS			
Total score	ns		
No. Groups	ns		
Average score	ns		
Condition	ns		
RHA			
Score	ns		
% transformed	ns		
Condition	ns		
In situ and chemical water quality		Clarity (cm)	59
Temperature (°C)	20.62	pH	7.3
Dissolved oxygen %	89.7	<i>E. coli</i> (mpn/100ml)	ns
Electrical Conductivity (mS/m)	7.0	Nitrate (mg/l)	ns
Total dissolved salts (mg/l)		Orthophosphate(mg/l)	ns
Description: This site is similar to site 35, the difference being that it was deeper and rockier. This was the last site assessed before the confluence of the Karkloof River with the uMgeni River. Access was not suitable for miniSASS and dangerous game were in the vicinity so the assessment was limited to in-situ water quality for this site. These results were all within the acceptable ranges. The condition of this site was similar, if not better, than site 35 and the overall condition is considered to be good.

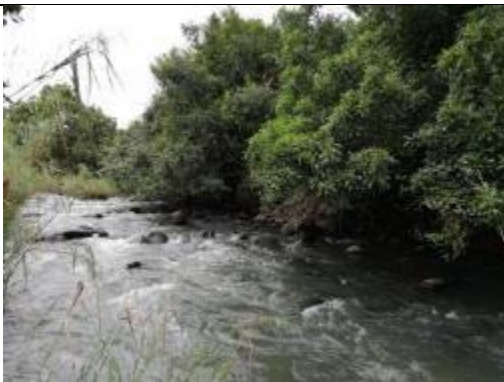
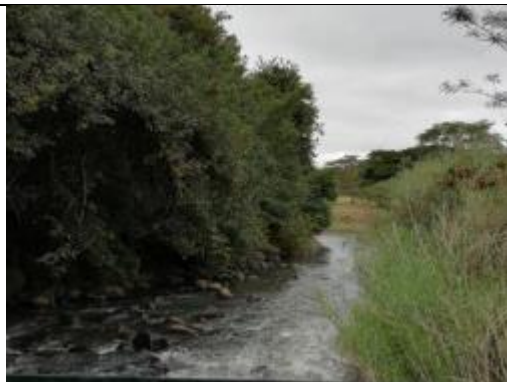
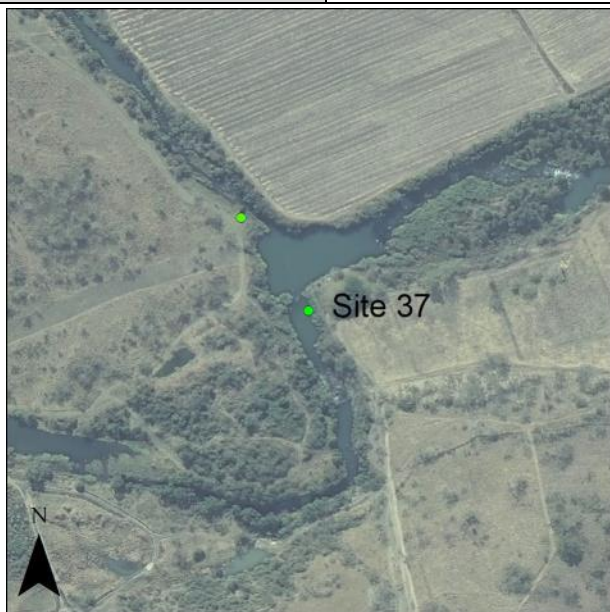
Upstream view from sample site		Downstream view from sample site	
Day 6	Site 37	Water Management Area	uMvoti to uMzimkhulu
River	Karkloof	1:50000 map reference	2930AD
Quaternary Catchment	U20E	Aquatic Ecoregion	South eastern Uplands
Latitude (S) DD	-29.44590

Longitude (E) DD	30.32090		
Aquatic Assessments			
MiniSASS			
Total score	na		
No. Groups	na		
Average score	na		
Condition	na		
RHA			
Score	11		
% transformed	27.5		
Condition	Good		
In situ and chemical water quality		Clarity (cm)	ns
Temperature (°C)	ns	pH	ns
Dissolved oxygen %	ns	E. coli (mpn/100ml)	ns
Electrical Conductivity (mS/m)	ns	Nitrate (mg/l)	ns
Total dissolved salts (mg/l)	ns	Orthophosphate(mg/l)	ns
Description: This RHA covered the river from the bridge near site 33 all the way down to the confluence with the uMgeni River past site 36 an ending at site 37. The RHA showed the reach to be in a good condition. There were diversion channels from the river to feed ponds, lantana was present in the riparian areas and the presents of man-made structures such as road crossings and a weir were found within the reach and these impacts prevented the site from scoring a near to natural result.
